January 24, 2007

Warranty Extension: Audio-HVAC Display Is Dim or Dark

(Supersedes 04-027, *Audio-HVAC Display Is Dim or Dark*, dated February 15, 2006.)

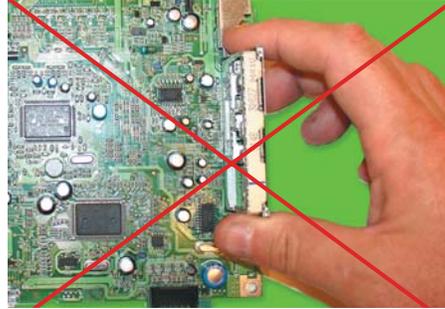
Never lift the PCB by the component parts.

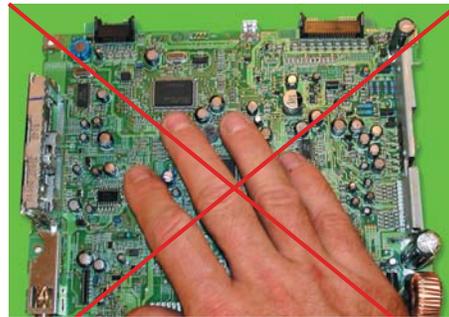
Never touch the electrical components of the PCB.

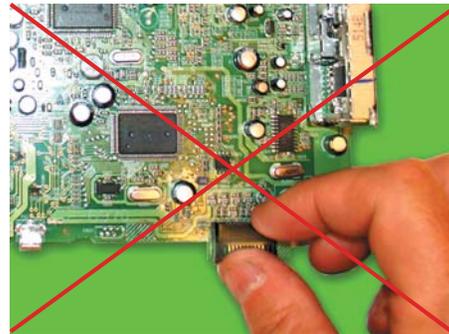
Never lift or hold the PCB by the connectors.

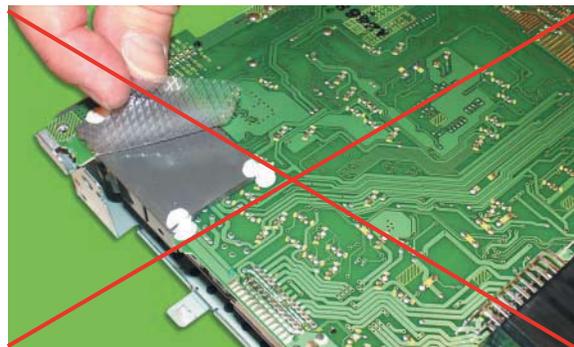
To prevent damage to the thermal pad, don't remove the protective cover until step 14.
