## Product Update: Front Balancer Shaft Oil Seal (Supersedes 00-073, dated October 6, 2000)

### BACKGROUND

The front balancer shaft oil seal may back out of the oil pump housing over time. If this happens, the oil can be rapidly pumped out of the engine without warning, causing serious engine damage if you continue to drive.

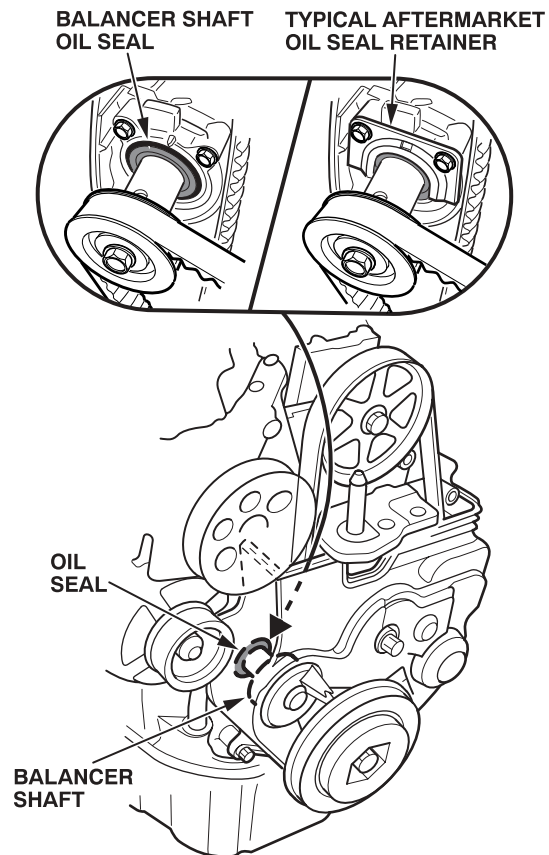
4. Use a flashlight to look inside the lower cover at the front balancer shaft oil seal. Look for an oil seal retainer above it bolted to the oil pump housing.
  - If you see an oil seal retainer, go to step 23.
  - If you do *not* see an oil seal retainer, go to step 5.
  - If the seal is cocked or backed out, replace the seal. Replace the timing belt and balancer belt if they are contaminated with oil (refer to section 6 of the appropriate service manual). Then go to step 14. *This repair requires DSM approval.*
  - If the oil seal has backed out, causing internal engine damage from extended driving with a complete loss of oil, contact your DSM.
