Shuttering / Quivering on Acceleration / Failing EGR Function Test or NOx Test

1990-1993 Accord L-4 Engine EGR Port Cleaning Procedure

1994 and Up Accord L-4 Engine EGR Port Cleaning Procedure

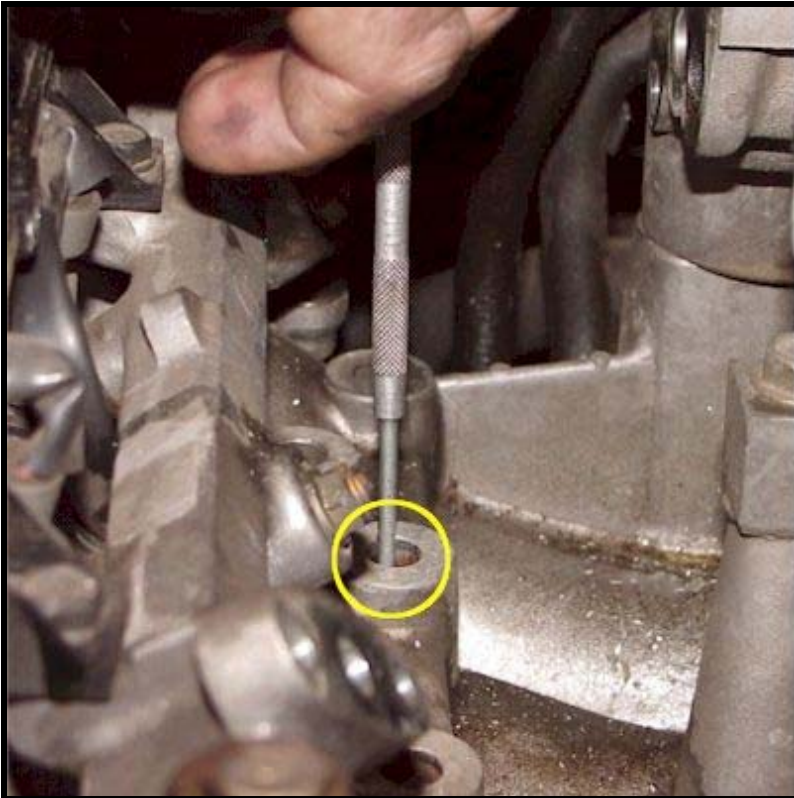
This is the hole where the exhaust gasses enter the intake runner.

Use a pick or drill bit to clean out the passageway. Go straight down and be sure and clear the hole at the bottom of the runner.
