Replacing the Upper Ball Joint & Upper Control Arm on a 2007 Honda Accord 4CYL

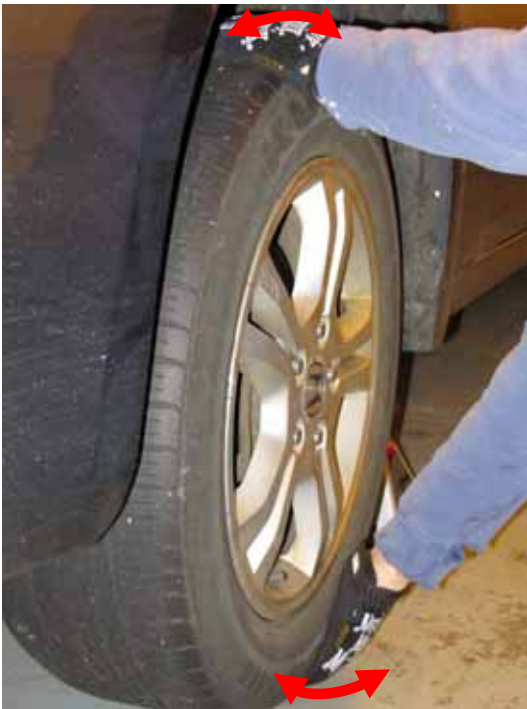
Typical symptoms of a bad upper ball joint include a “clunking” noise when driving over bumps and a poor tire wear pattern. The upper ball joint can be checked by grabbing the wheel at the 12:00 and 6:00 positions (as shown below) and shaking to check for play.

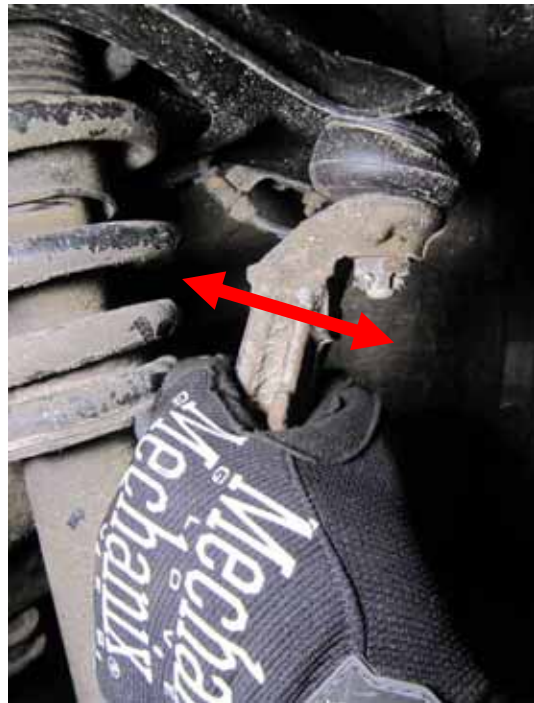
To check if the play is in the upper ball joint, remove the wheel and grab the upper part of the knuckle as shown below. If you shake it back and forth as shown, you should not see any movement in the upper ball joint. If you see/feel any movement in the ball joint, it is likely that the ball joint is bad. In my case, I could see a small but definite movement in the joint.

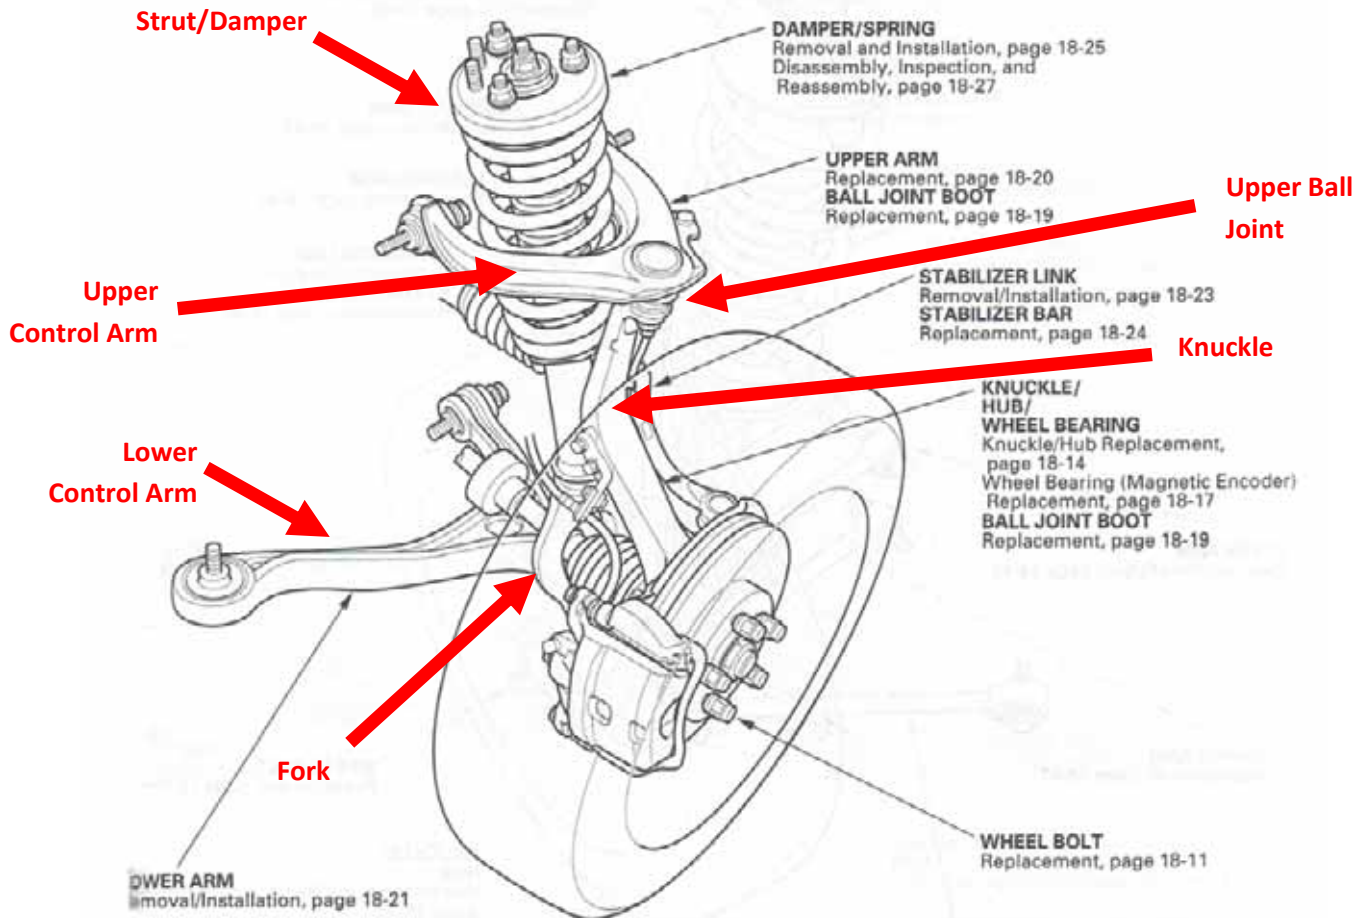
The figure below shows the front suspension components. The upper ball joint is not available separately from the upper control arm (at least not from Honda) so the entire upper control arm needs to be replaced (around \$60 for the OEM part online).

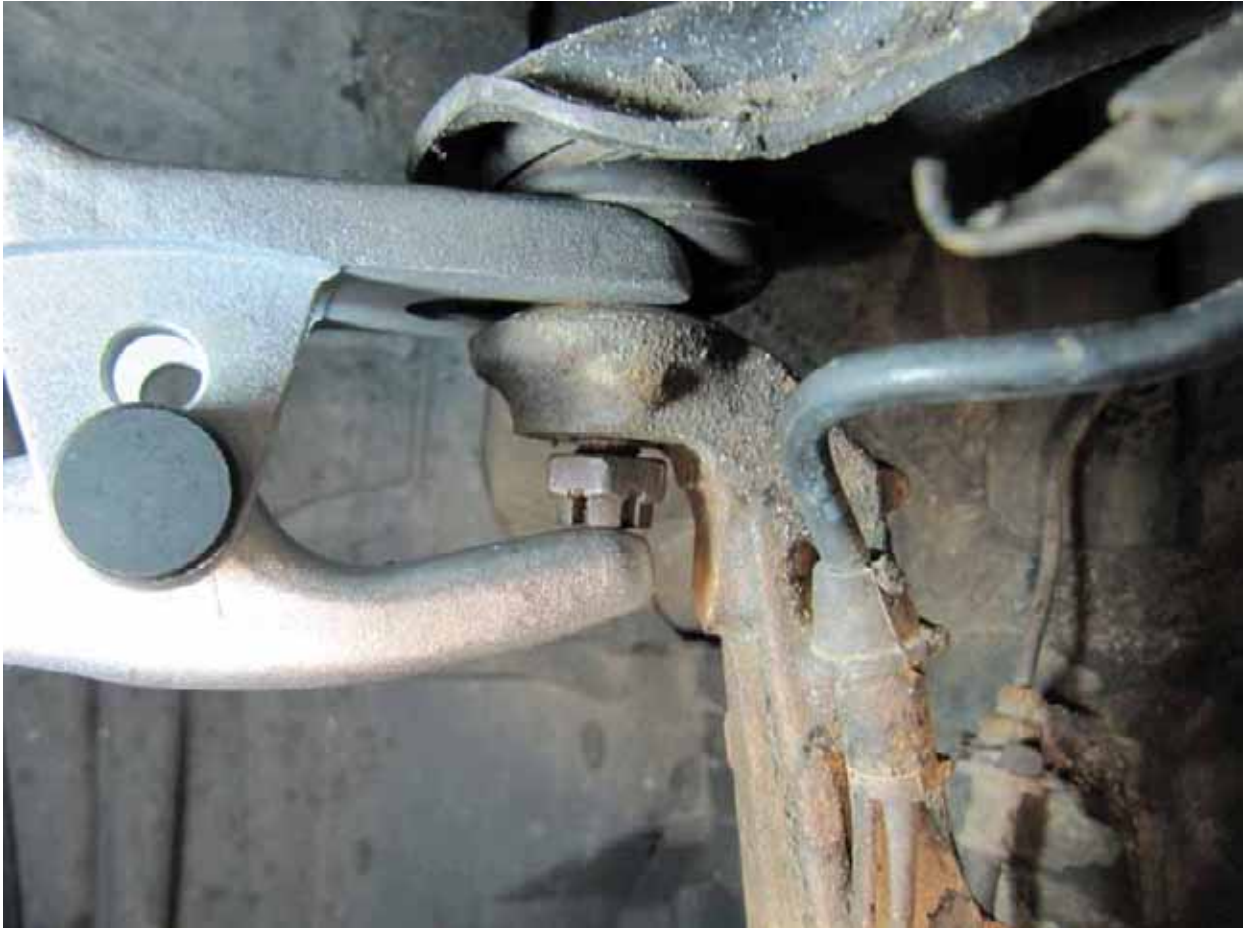
#16 – Side view showing placement of the ball joint separator.

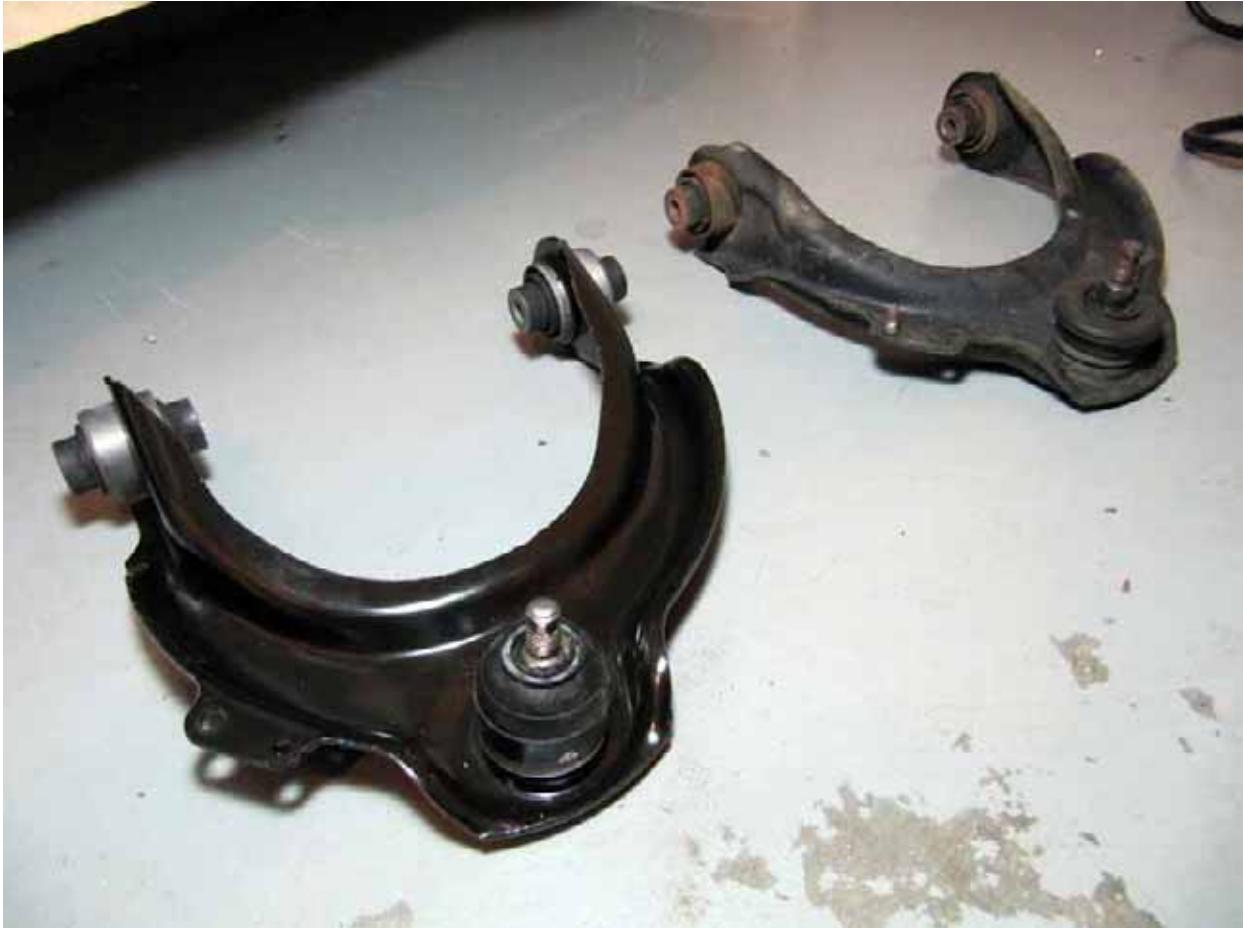
#20 – Compare the new and old parts to make sure you got the right one!

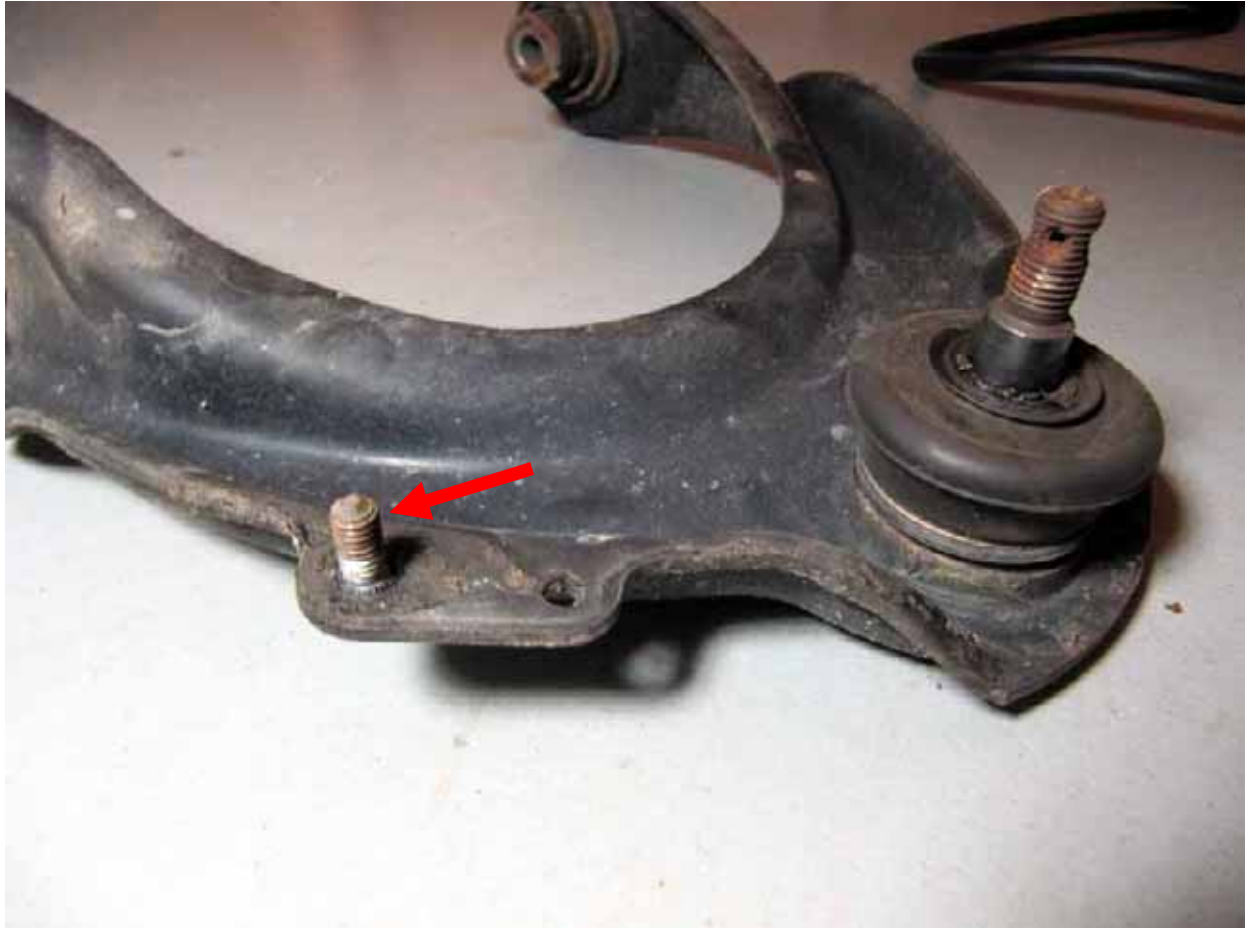
#21 – My new upper control arm didn't come with the bolt for the ABS wire bracket installed (red arrow), so I had to remove the bolt from the old upper control arm.

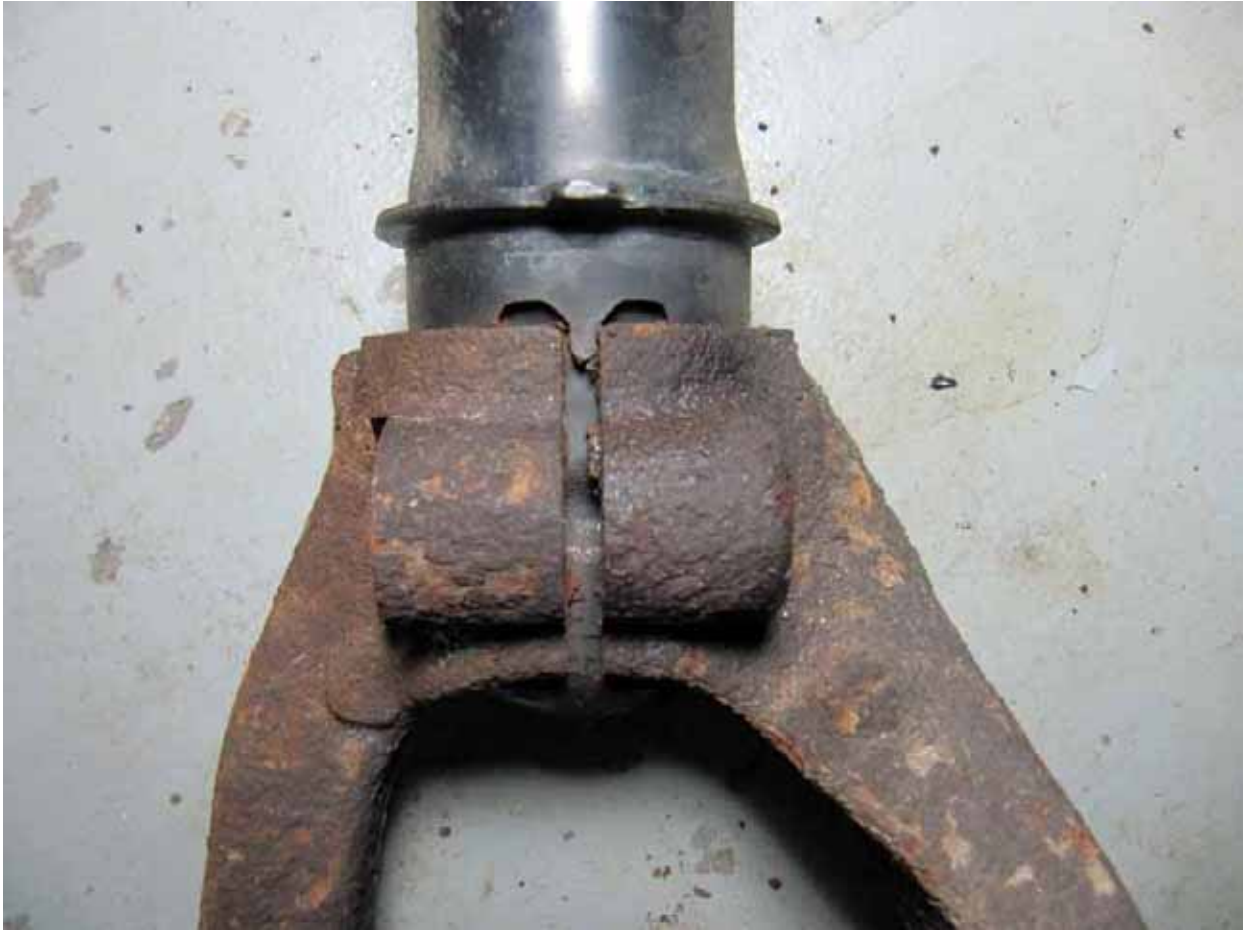
#33 – Here is a zoomed in view showing what it looks like when the strut is fully inserted into the fork.

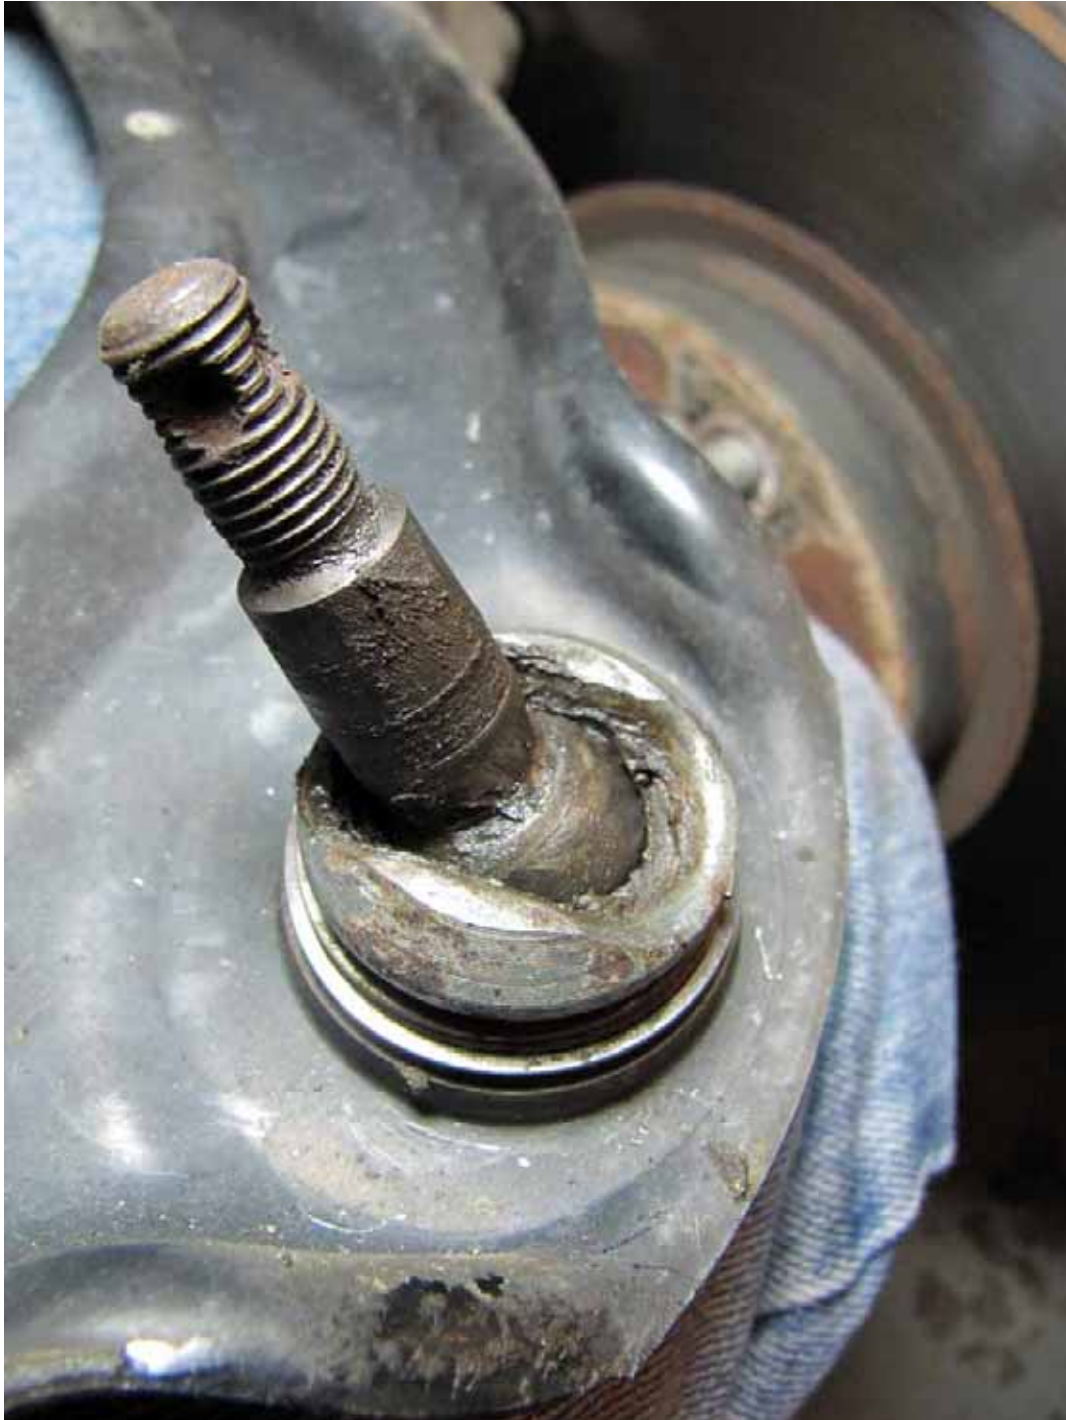
#44 – In case you are curious, here is what it looks like inside the bad ball joint with the boot and grease removed. There was a small amount of play which could be felt and the pin moved around much more freely than the new one. Still looks like it would have been a while before my wheel fell off :)
