Applies To: **2000 Accord EX L4** – ALL (with cloth interior only)

## SRS Indicator On With DTC 9-3 or Driver's Seat Belt Buckle Replacement (Supersedes 01-055, dated July 3, 2001)

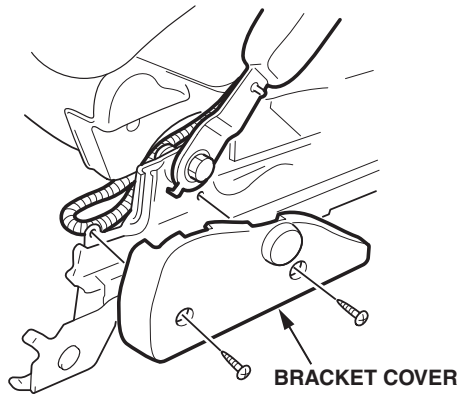
7. Remove the bracket cover.

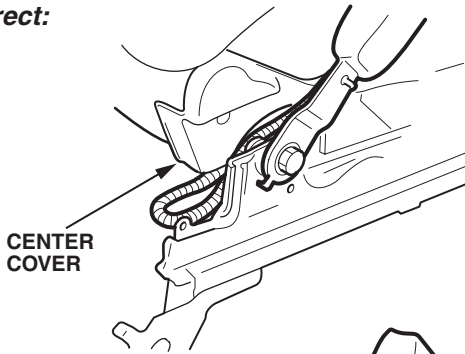
**Correct:**

8. Inspect the seat belt buckle harness at the rear inside corner of the seat rail near the area where the seat belt buckle is anchored to the seat frame.

- If the harness is correctly routed outside the center cover, go to step 16.
- If the harness is incorrectly routed inside the center cover, go to step 9.

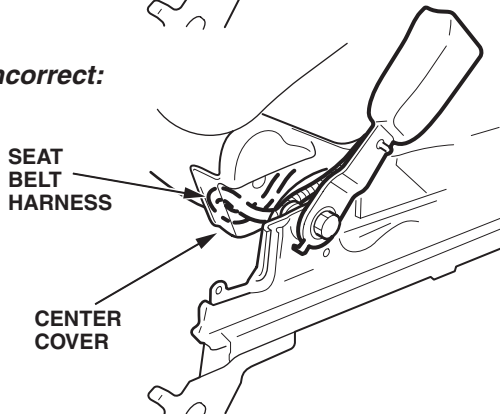
**Incorrect:**

The driver's side seat belt buckle harness may be pinched underneath the center cover, or the harness may be misrouted inside the center cover.

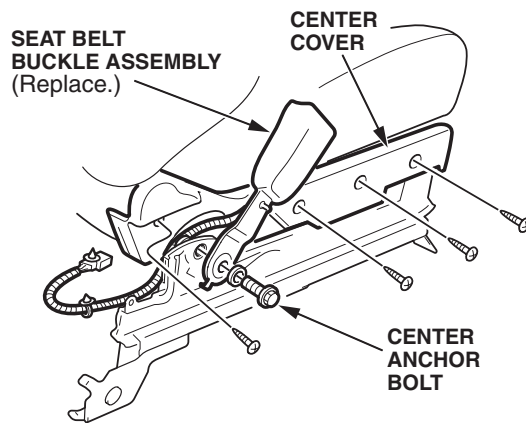
11. Remove the center anchor bolt.

12. To avoid distorting the center cover, remove it; then remove the seat belt buckle harness.

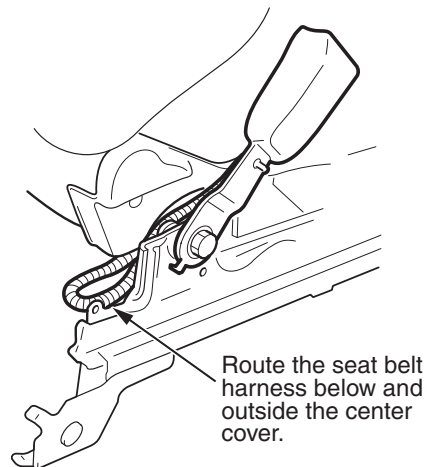
15. Install the new seat belt buckle assembly, and carefully route the harness below and outside the center cover. Torque the center anchor bolt to 32 N·m (24 lb-ft).
