1996 Honda Accord F22B2 Engine

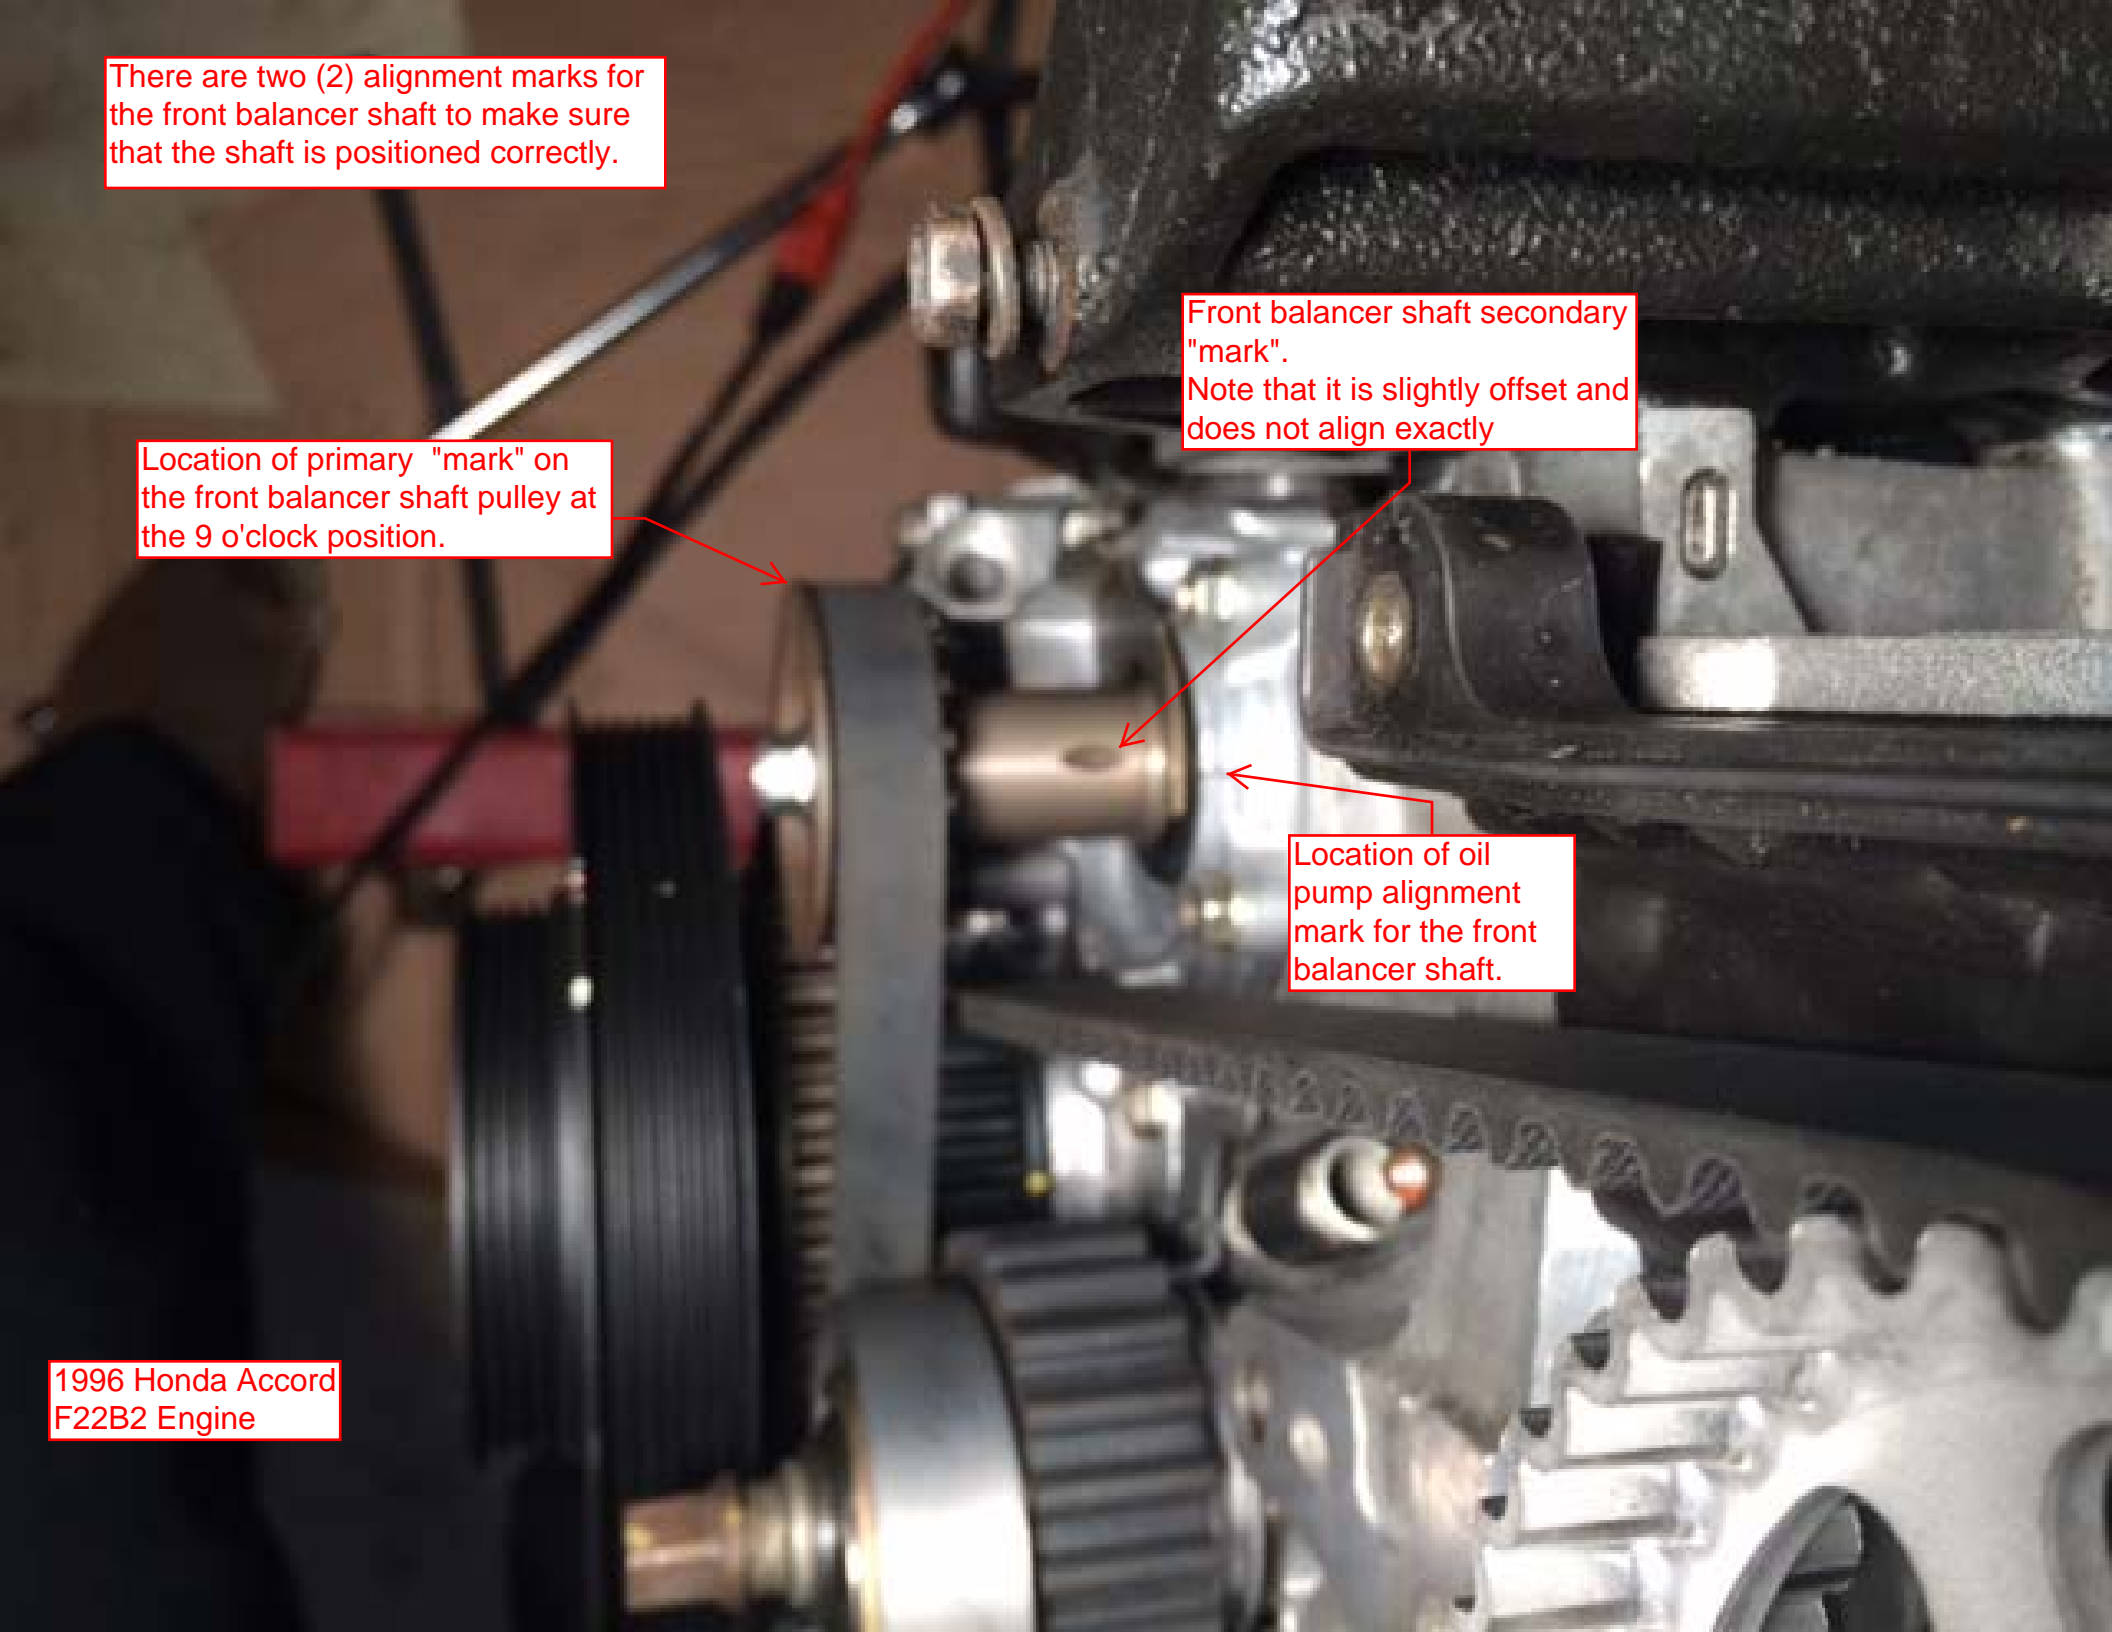
There are two (2) alignment marks for the front balancer shaft to make sure that the shaft is positioned correctly.

Location of primary "mark" on the front balancer shaft pulley at the 9 o'clock position.

Front balancer shaft secondary "mark". Note that it is slightly offset and does not align exactly

Location of oil pump alignment mark for the front balancer shaft.
