Applies To: **See VEHICLES AFFECTED**
June 30, 2007

Center Pocket Lid Does Not Open or Close Properly

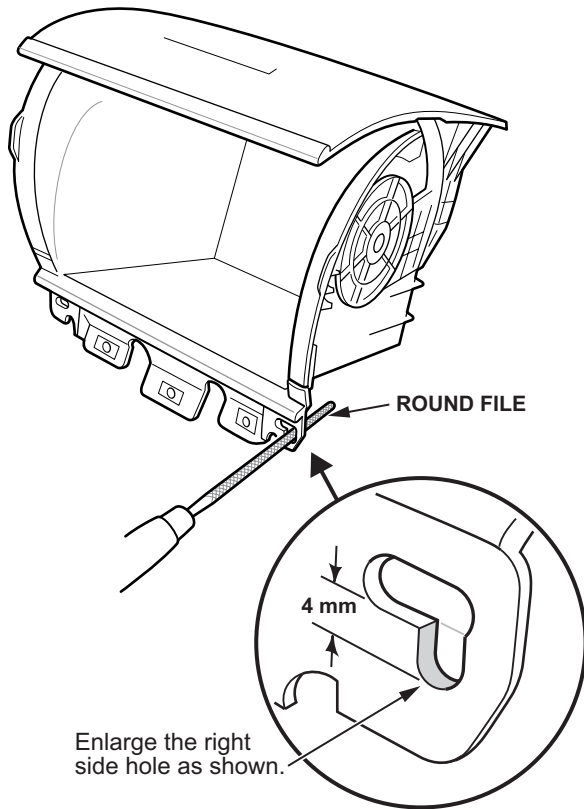
1. Remove the center pocket assembly:
 - Refer to page 20-132 of the *2003–2007 Accord Service Manual*, or
 - Online, enter keyword **POCKET**, and select **Dashboard Center Pocket Removal/Installation** from the list.
2. Using a round file, elongate the right mounting screw hole as shown.

NOTE: Do not use a file larger than 4.0 mm, and do not elongate the hole more than 4.0 mm.

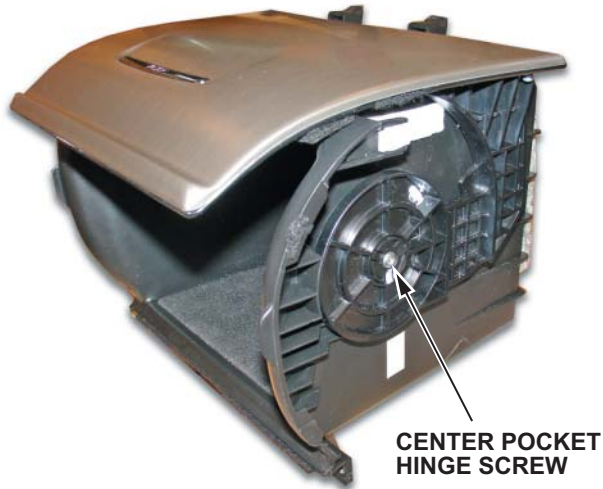
RIGHT SIDE OF THE CENTER POCKET

1. Remove the center pocket assembly:
 - Refer to page 20-132 of the *2003–2007 Accord Service Manual*, or
 - Online, enter keyword **POCKET**, and select **Dashboard Center Pocket Removal/Installation** from the list.
2. Tighten the center pocket hinge screws and the G-sensor screw.
