ATB 51252 REV-1 (1406)

## Driver's Power Seat And Seat Memory Settings Do Not Work Properly

### AFFECTED VEHICLES

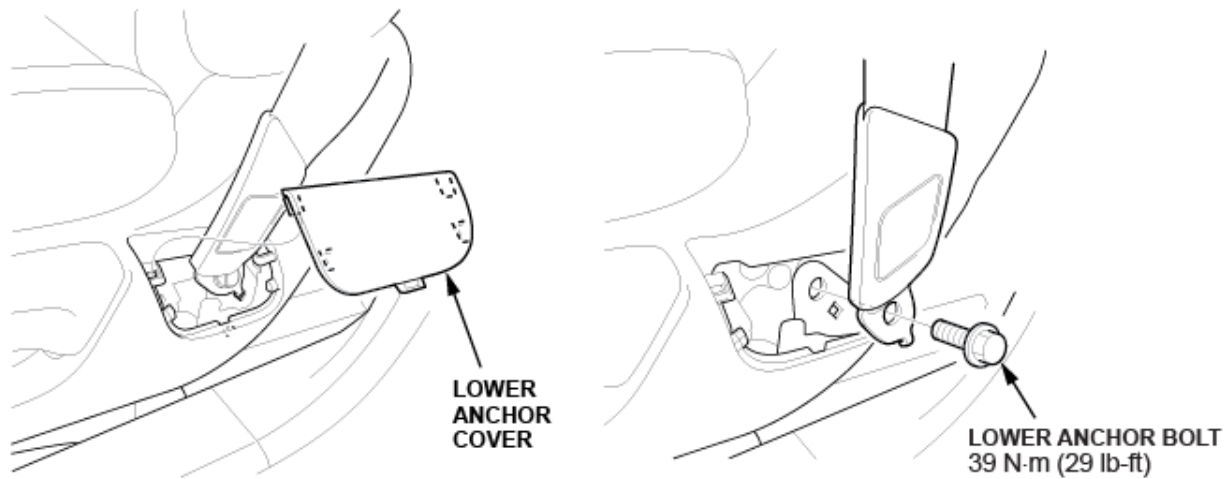
1. Remove the driver's seat belt lower anchor bolt.

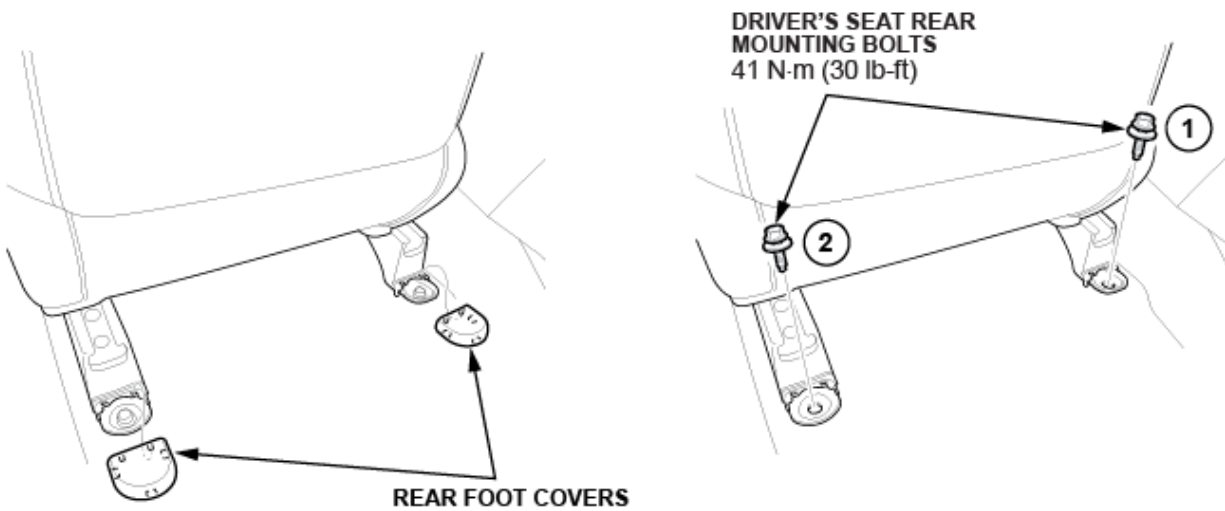
2. Remove the driver's seat rear foot covers and rear mounting bolts.

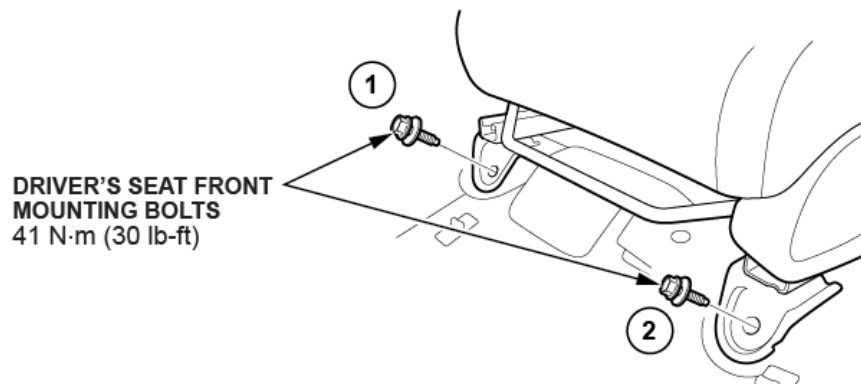
3. Move the driver's seat all the way back.
4. Remove the driver's seat front mounting bolts.

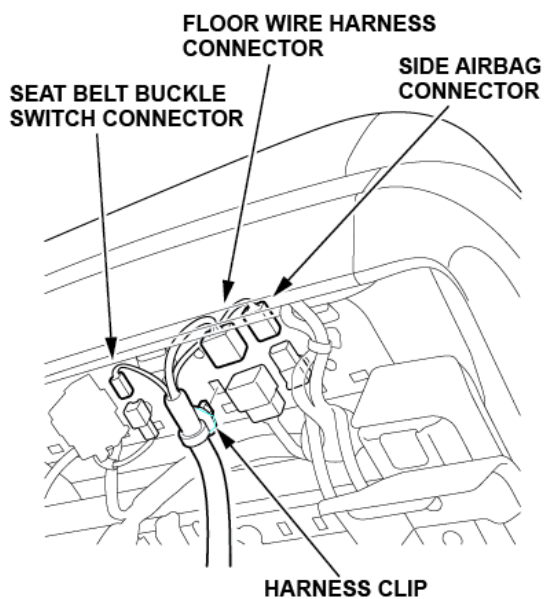
**2-DOOR**

6. Lift up the front seat, disconnect the connectors, and release the harness clip.

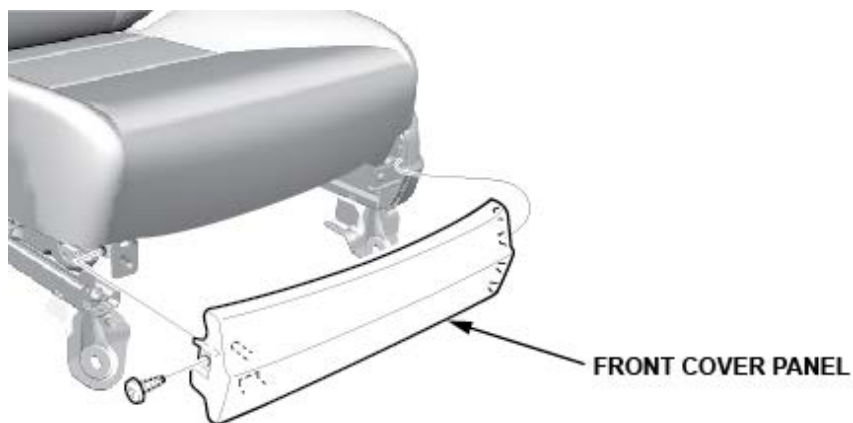
8. Remove the driver's seat front cover panel.

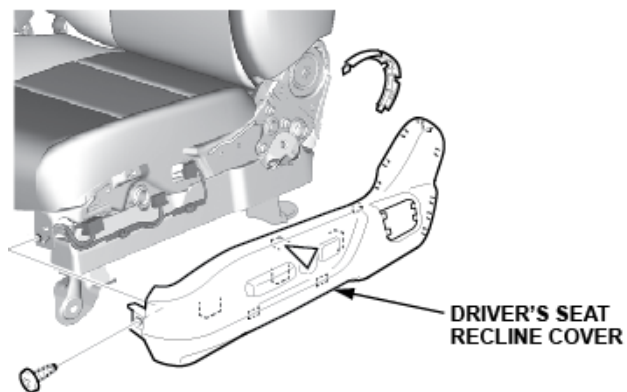
9. Remove the driver's seat recline cover.

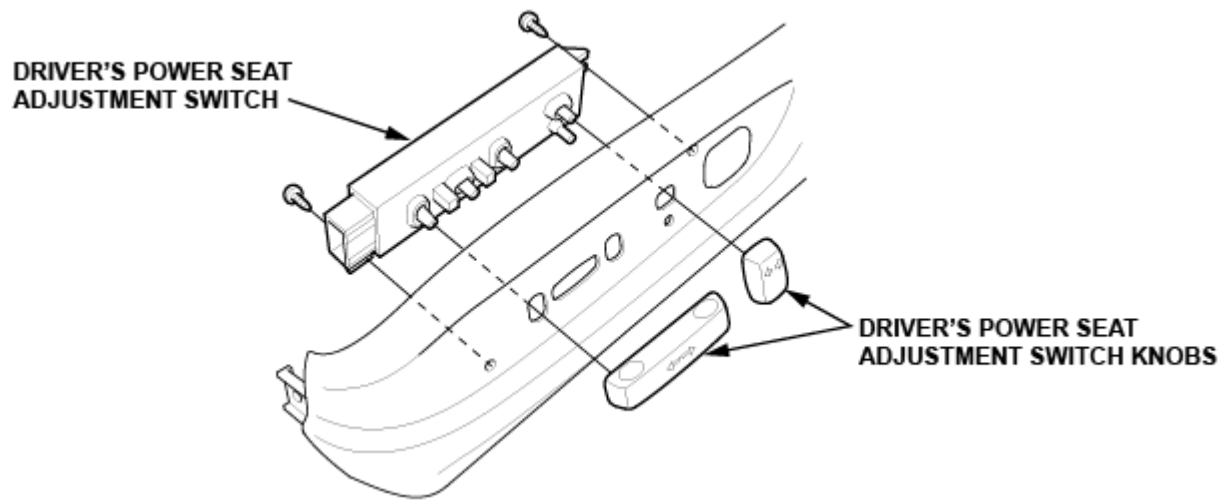
10. Remove the driver's power seat adjustment switch knobs, then remove the driver's power seat adjustment switch.

11. Install the new driver's power seat switch.

12. Reinstall all parts in the reverse order of removal, and reconnect the battery negative cable.
