Replacing the Upper Ball Joint & Upper Control Arm on a 2007 Honda Accord 4CYL

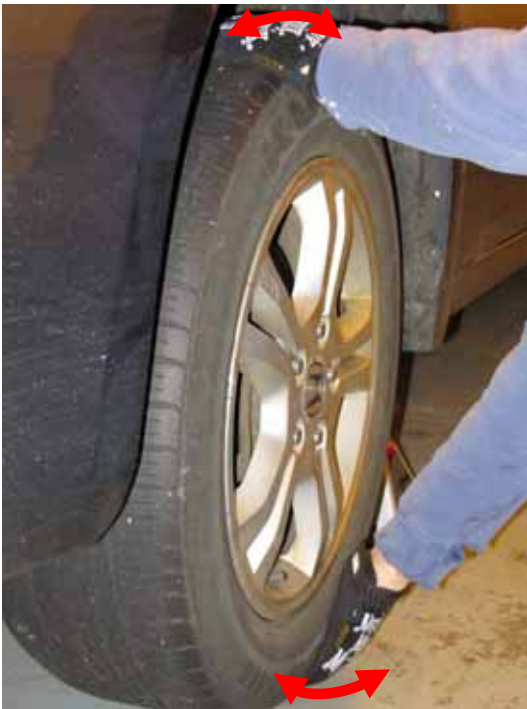
Typical symptoms of a bad upper ball joint include a “clunking” noise when driving over bumps and a poor tire wear pattern. The upper ball joint can be checked by grabbing the wheel at the 12:00 and 6:00 positions (as shown below) and shaking to check for play.

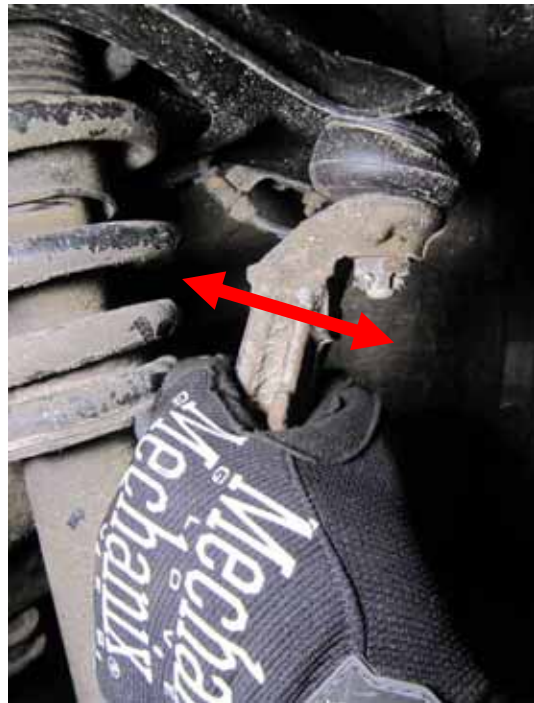
To check if the play is in the upper ball joint, remove the wheel and grab the upper part of the knuckle as shown below. If you shake it back and forth as shown, you should not see any movement in the upper ball joint. If you see/feel any movement in the ball joint, it is likely that the ball joint is bad. In my case, I could see a small but definite movement in the joint.

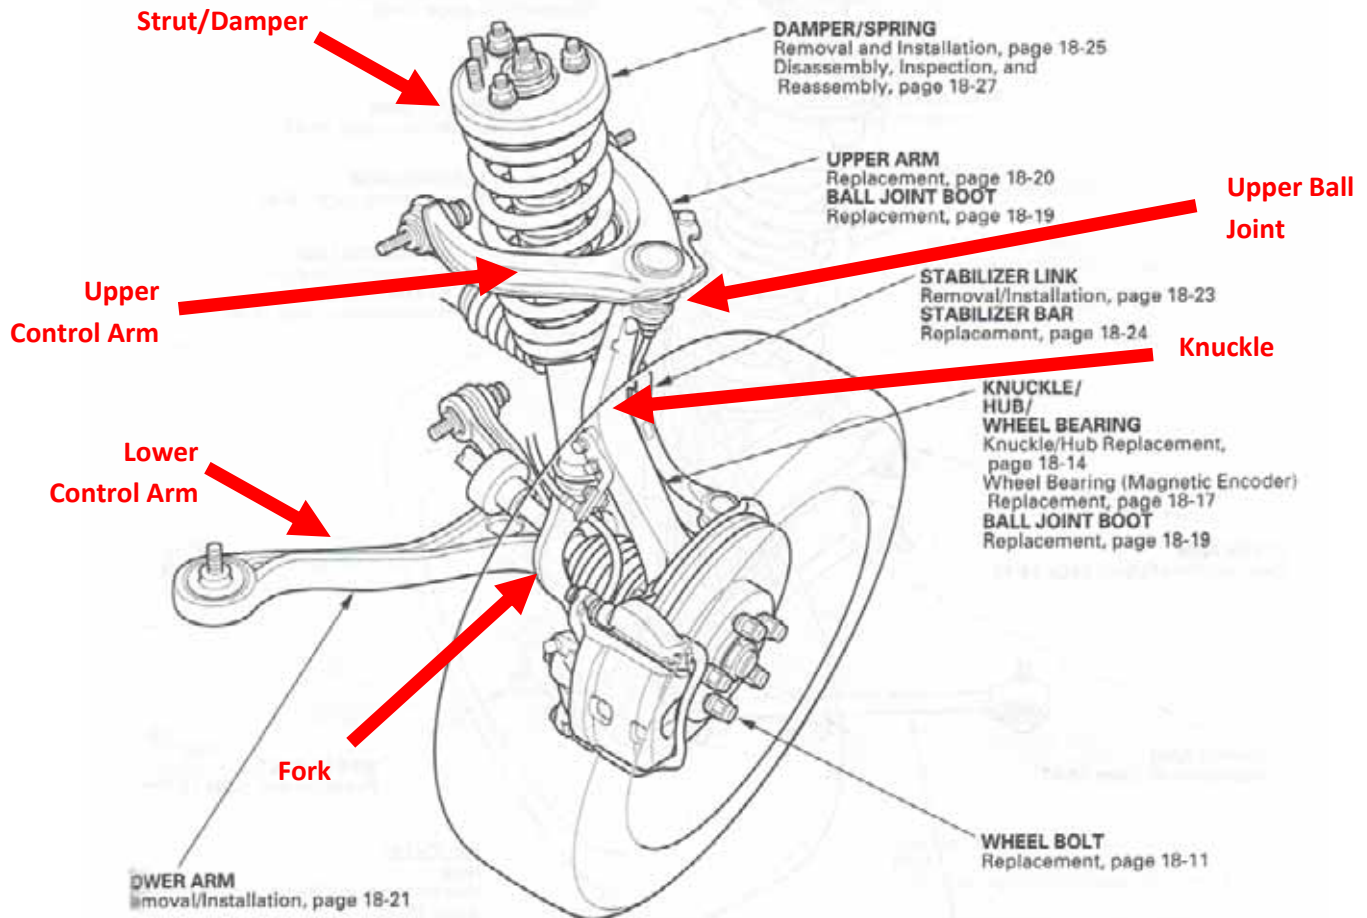
The figure below shows the front suspension components. The upper ball joint is not available separately from the upper control arm (at least not from Honda) so the entire upper control arm needs to be replaced (around \$60 for the OEM part online).

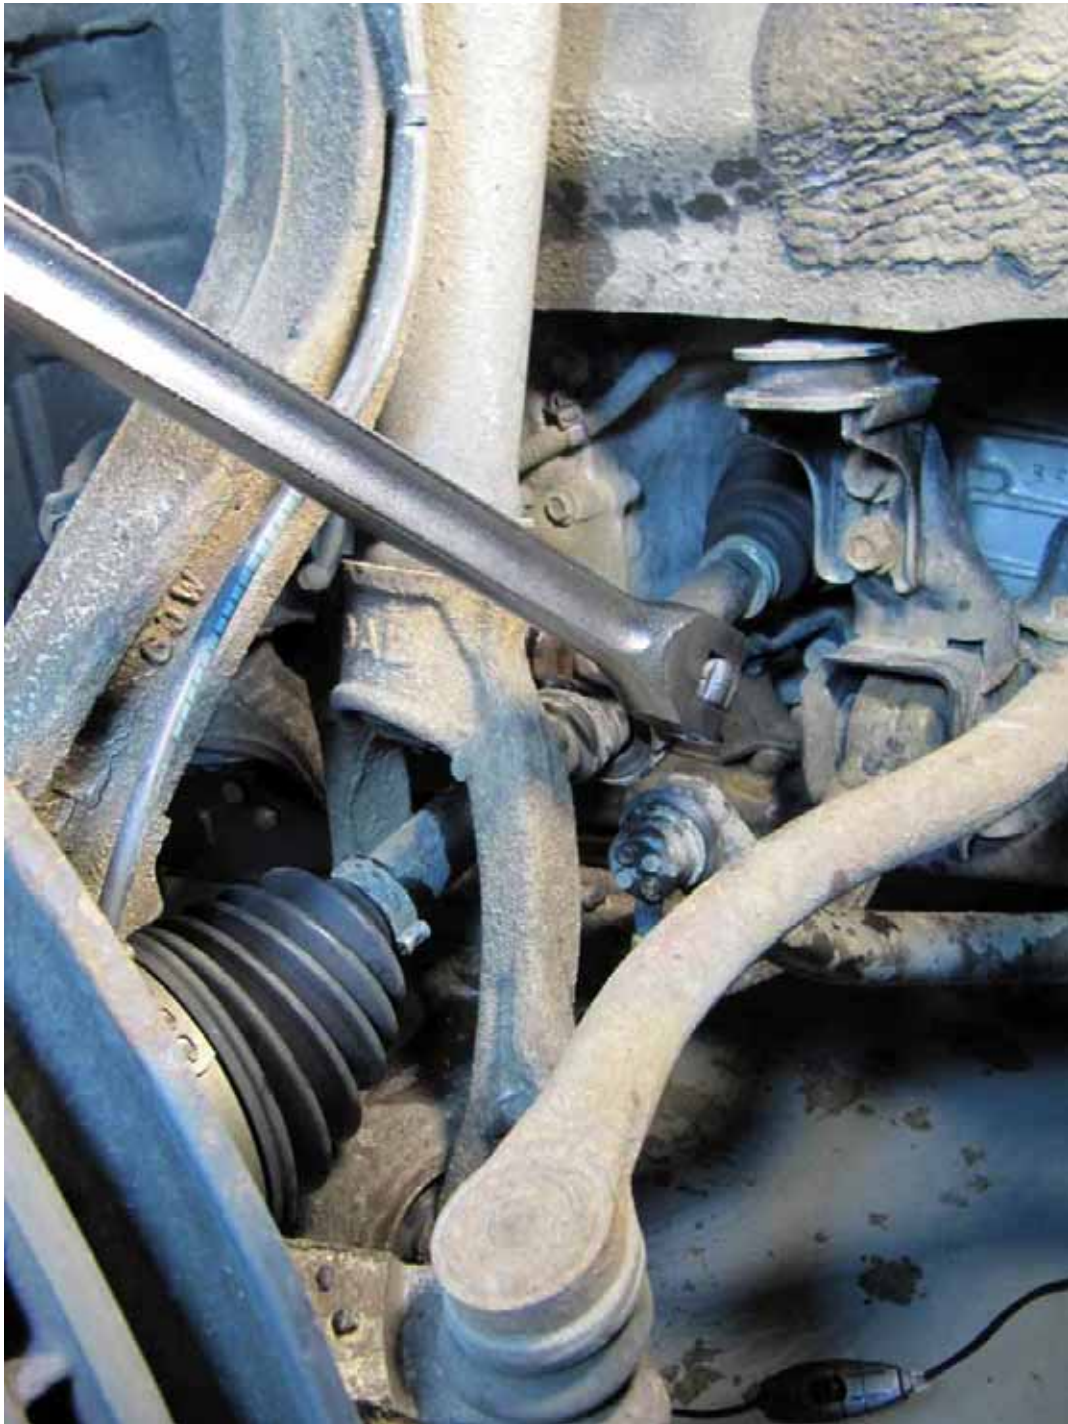
1. The Pinch bolt gets VERY corroded in place and can be VERY difficult to remove. This is because the pinch area and the open end allow moisture to enter and really freeze this bolt in place. You are probably best off to use an impact wrench on this bolt. However, it is possible to shear the head off even with an impact wrench – don't ask me how I know this :). I would recommend soaking the pinch bolt in penetrating oil. Be sure to spray the head, bolt bottom and in the pinch region of the fork (the gap that gets pinched when the bolt is tightened). It will probably work best if you do this a few times over a period of a few days to give the penetrating oil plenty of time to penetrate before trying to loosen it.

#4 – Remove the pinch bolt holding the strut to the fork.

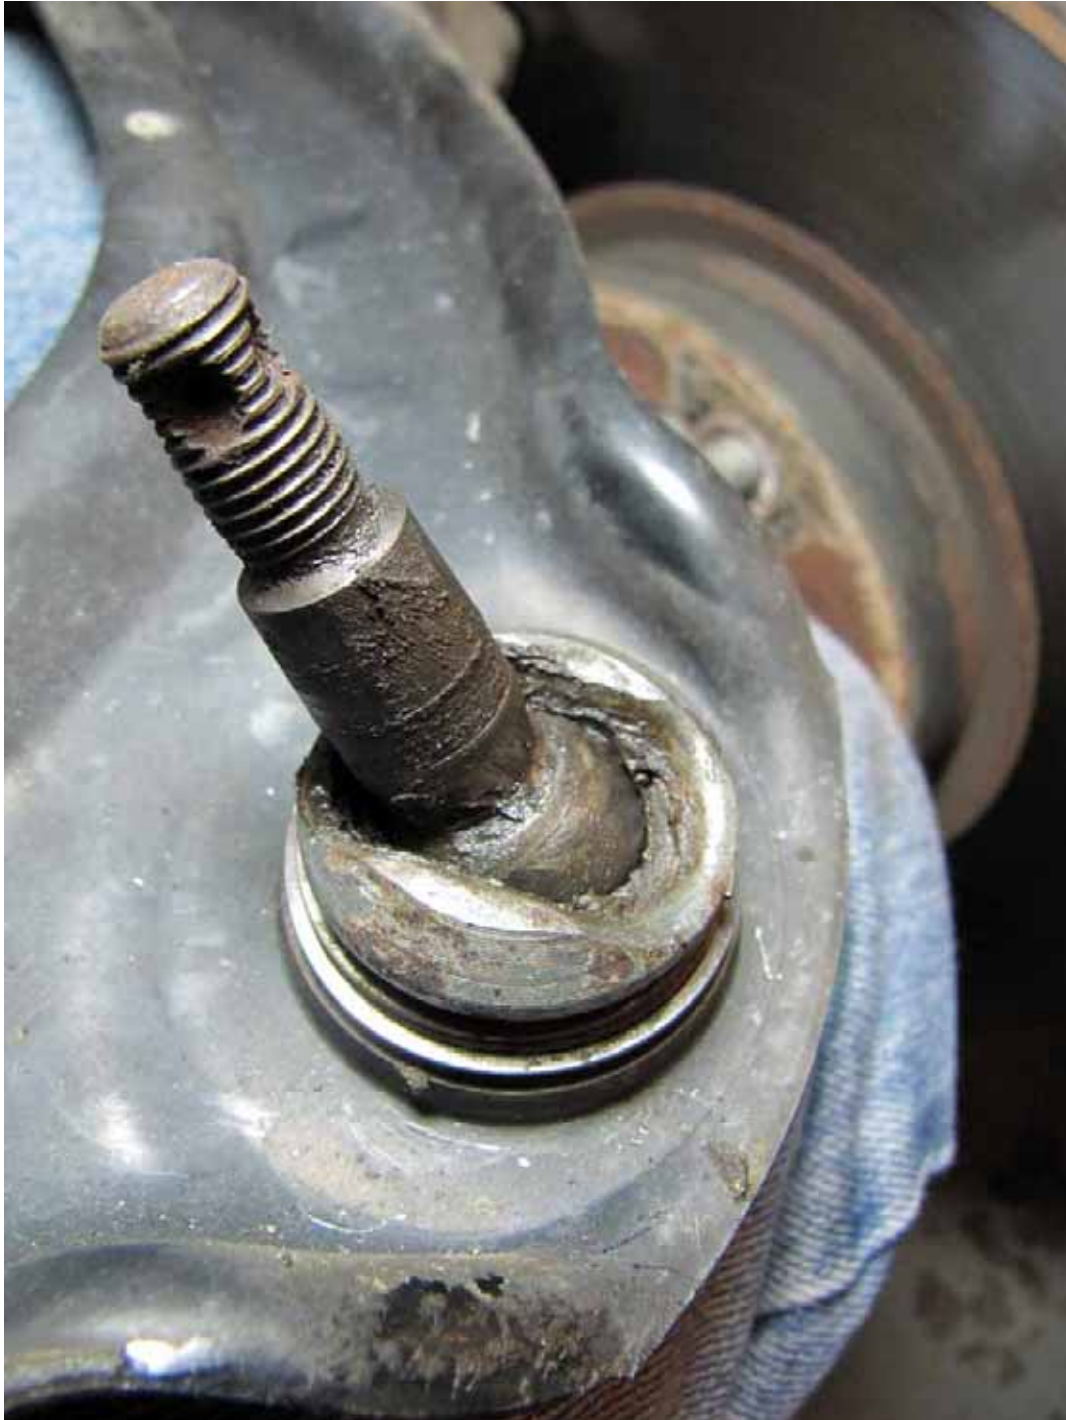
#44 – In case you are curious, here is what it looks like inside the bad ball joint with the boot and grease removed. There was a small amount of play which could be felt and the pin moved around much more freely than the new one. Still looks like it would have been a while before my wheel fell off :)
