## Warranty Extension: MIL Comes On With DTCs P0301 Through P0304

The piston rings on certain cylinders may rotate and align which can lead to spark plug fouling. This can set DTCs P0301 through P0304 and cause the MIL to come on.

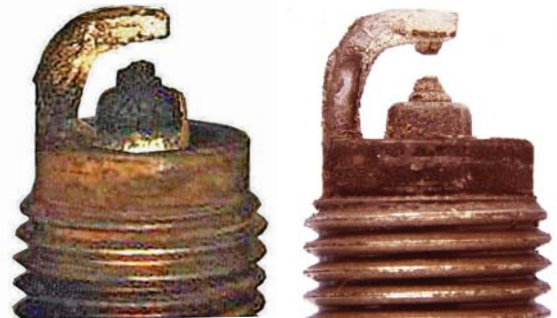
NOTE: Below are examples of good and fouled spark plugs.

**GOOD**

**NO GOOD**

3. Remove and check spark plug(s) on the affected cylinders (example: if P0301 is stored, check the spark plug on cylinder No. 1).
  - If the spark plug(s) are not fouled, this bulletin does not apply. Continue with normal troubleshooting.
  - If this vehicle has any of the above DTCs, the spark plug(s) are fouled, and the software is an earlier version, go to REPAIR PROCEDURE A.
  - If this vehicle has any of the above DTCs, the spark plug(s) are fouled, and the software is a current or later version, go to step 4.

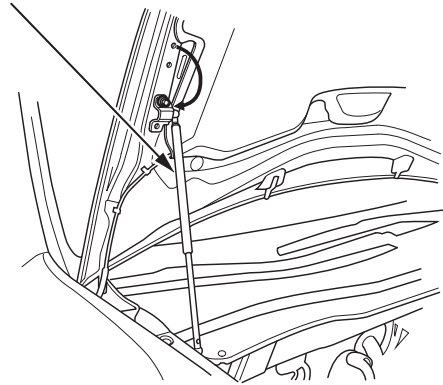
### HOOD SUPPORT STRUT

- Use fender covers to avoid damaging painted surfaces.
  - To avoid damaging any wires and terminals, unplug the circuit connectors carefully while holding the connector portion.
  - Mark all the circuits and hoses to avoid misconnection. Make sure they do not contact other circuit wiring, hoses, or interfere with other parts.
1. Using both hood support struts prop up the hood in a wide open position.

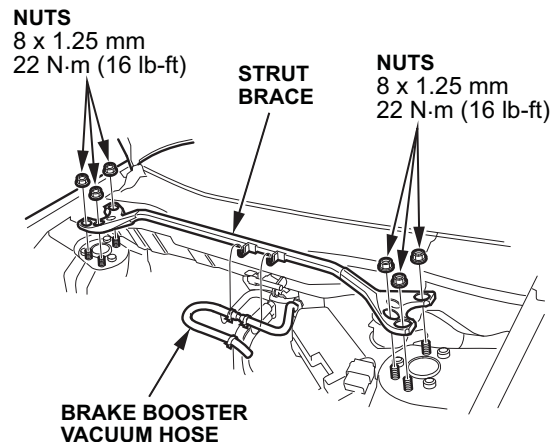
2. Relieve the fuel pressure.
3. Remove both front wheels so you can fully lower the vehicle.
4. Remove the strut brace.

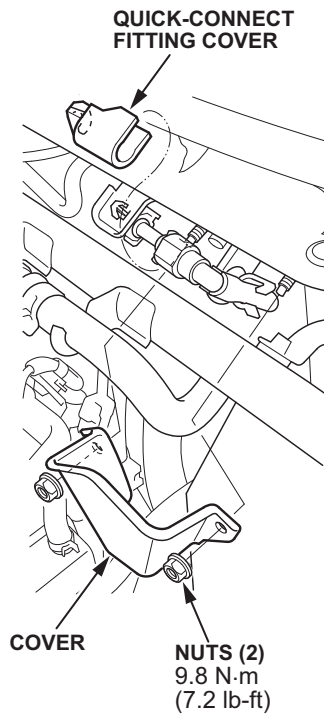
6. Disconnect the fuel feed hose line at the bulkhead.

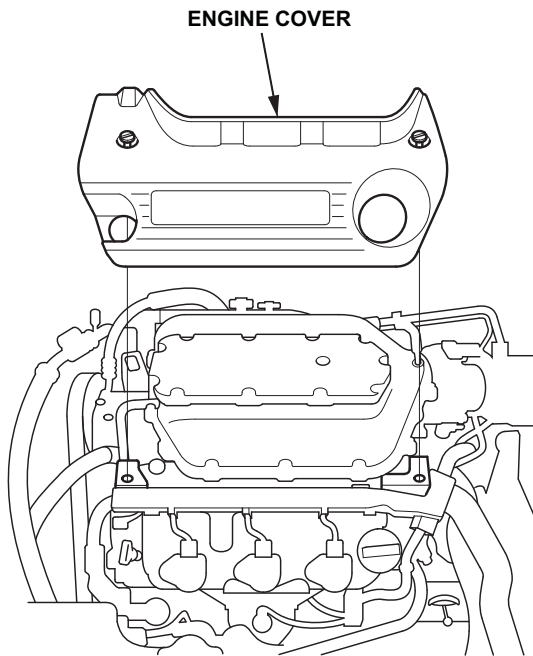
7. Remove the engine cover.

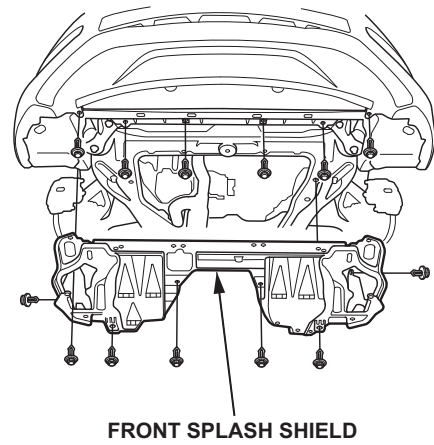
10. Remove the front splash shield.

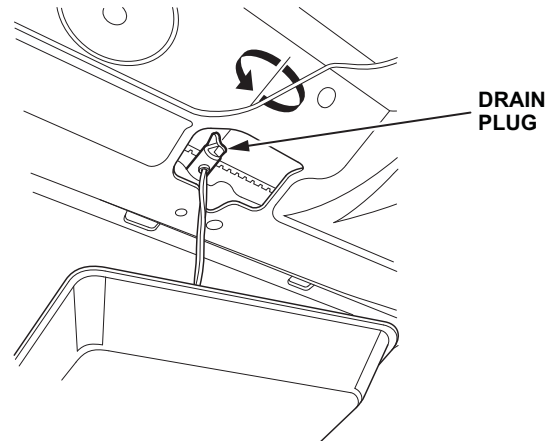
12. Loosen the drain plug on the radiator, and drain the coolant.

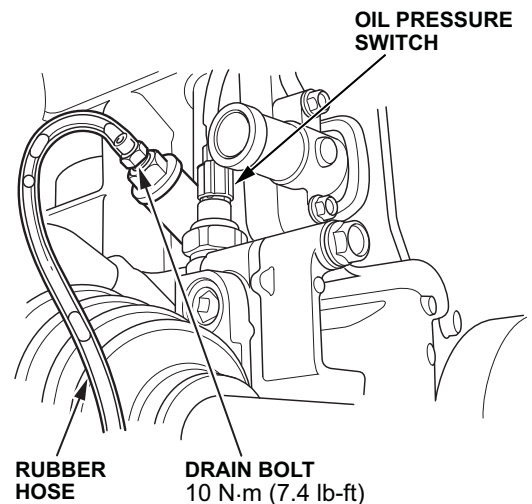
13. Install a 5/16th inner diameter rubber hose on the drain bolt located at the rear of the engine block, loosen the drain bolt, and drain all remaining coolant. Then disconnect the oil pressure switch connector.

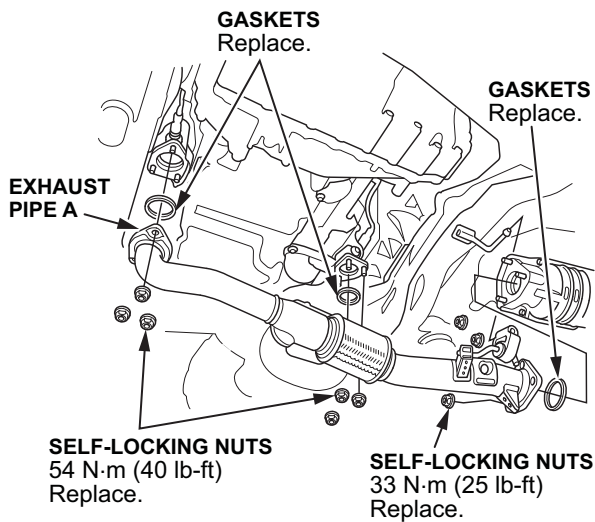
14. Remove exhaust pipe A.

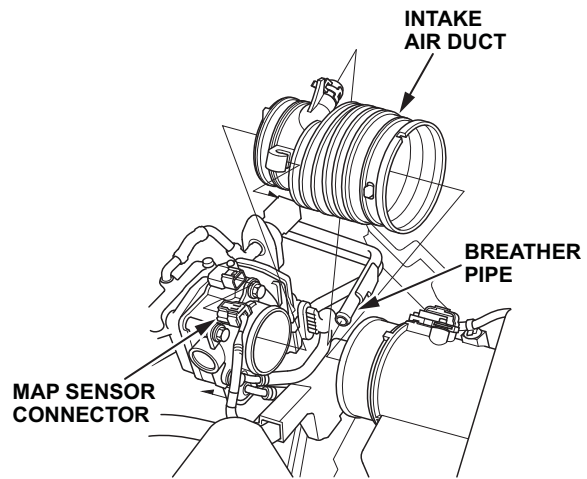
19. Disconnect the MAP sensor connector and the breather pipe, then remove the intake air duct.

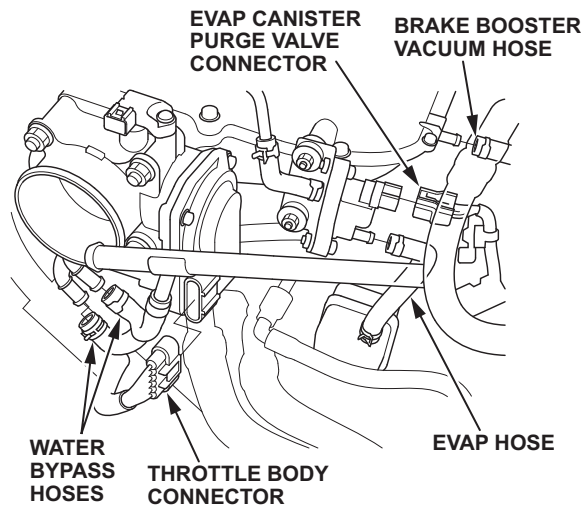
20. Disconnect the throttle body connector, the EVAP canister purge valve connector, the EVAP hose, the brake booster vacuum hose, and the vacuum hose.

21. Disconnect and plug the water bypass hoses.

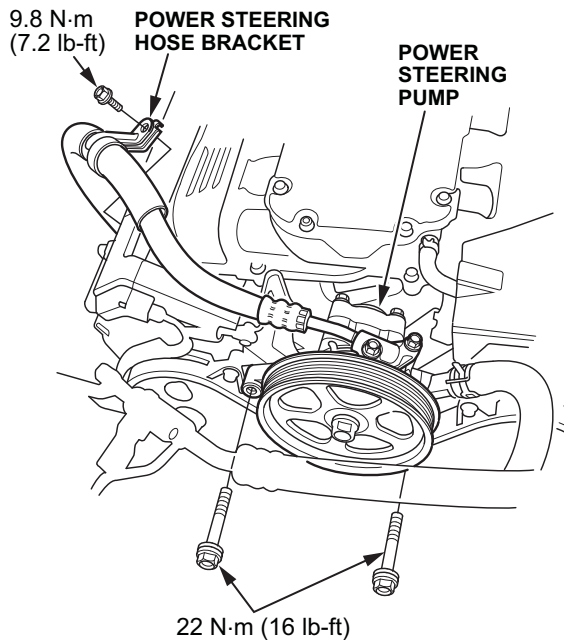
24. Remove the power steering pump bolts, the power steering bracket then secure the power steering pump out of the way.

NOTE: Do not remove any of the hoses.

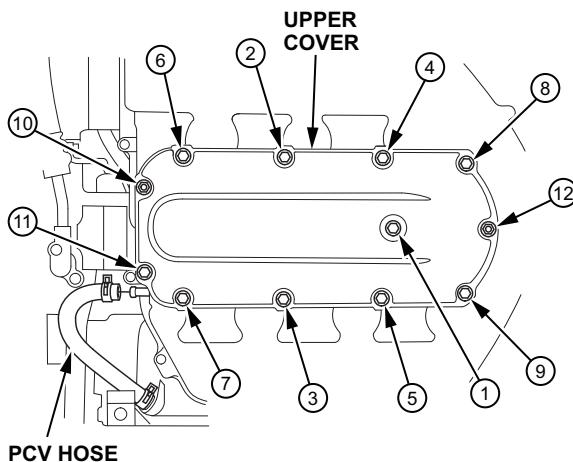
25. Remove the engine harness holder bolt on the side engine mount.
26. Set the engine to TDC cylinder one.
27. Remove the crankshaft pulley.
28. Remove the timing belt.
29. Remove the timing belt idler pulley.
30. Remove the engine intake upper cover bolts and nuts. Then remove the cover and the PCV hose.

**SPECIFIED TORQUE**  
6 x 1.0 mm  
12 N-m (8.7 lb-ft)

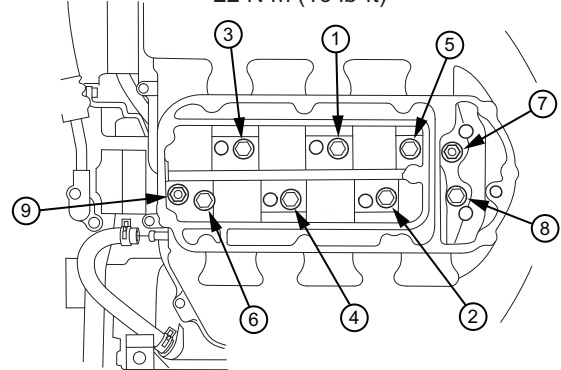
31. Remove the intake manifold bolts and nuts in three steps, then remove the intake manifold.

**SPECIFIED TORQUE**  
22 N-m (16 lb-ft)

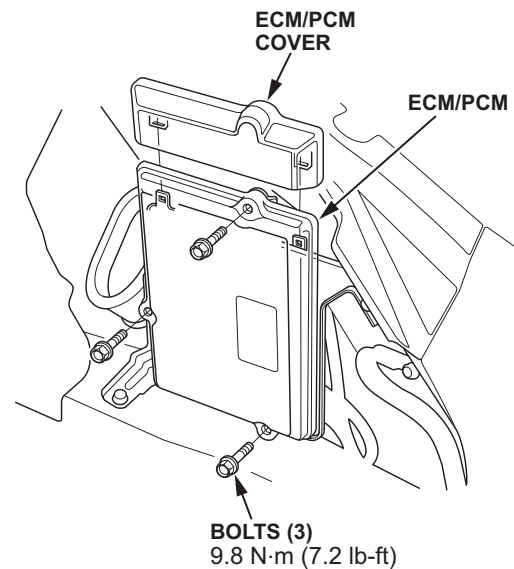
32. Remove the PCM cover.

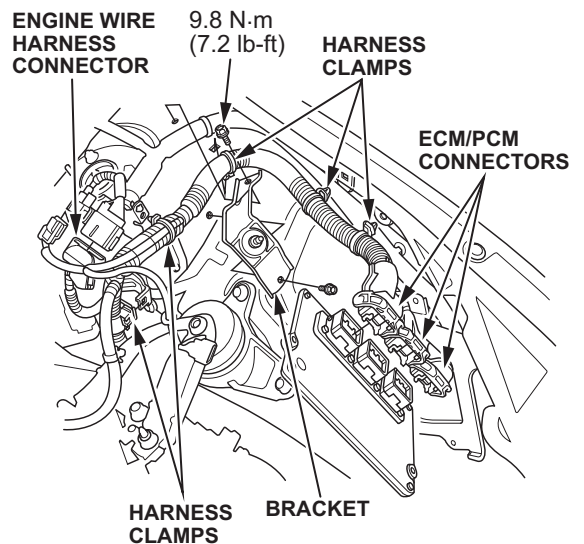
33. Remove the PCM connectors and harness clip. Remove the battery cables from the underhood fuse box.

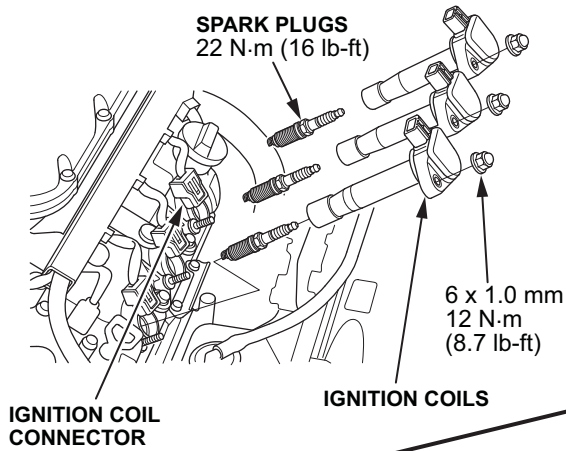
**FRONT**

34. Remove the appropriate Ignition coils based on the diagnosis.

NOTE: Depending on the diagnosis, you will either have to remove the rear bank ignition coils or both ignition coil banks.

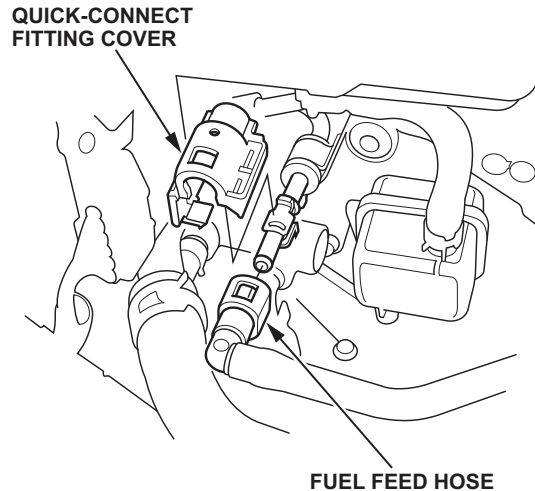
36. Remove the quick-connect fitting cover, then disconnect the fuel feed hose.

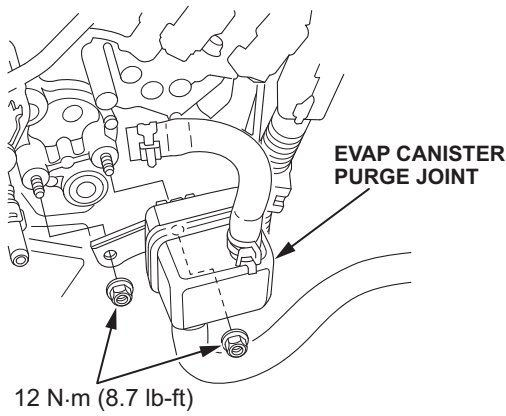
37. Remove the EVAP canister purge joint with the bracket.

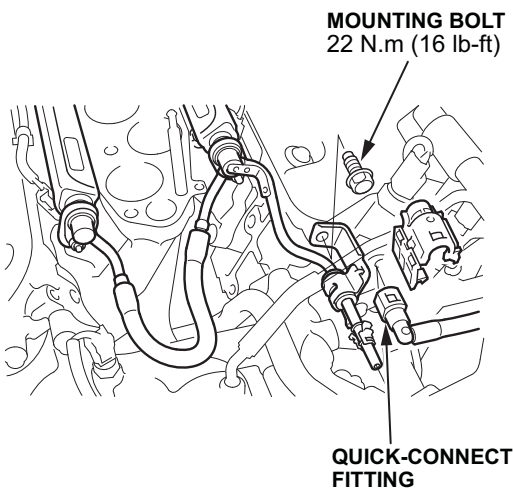
38. Remove the fuel rail connecting joint hose.

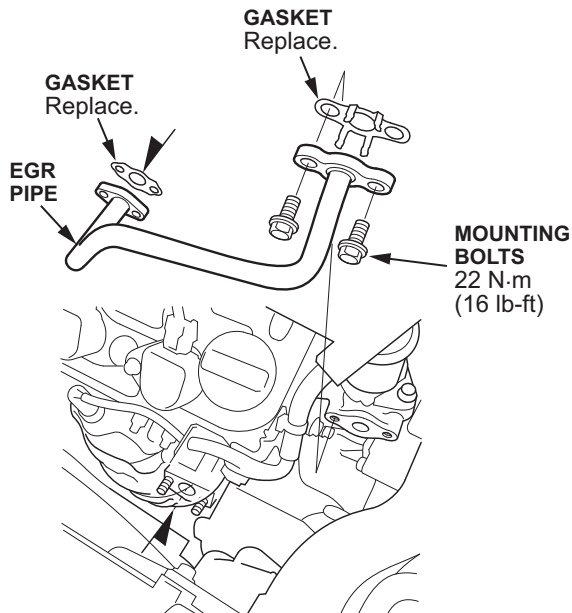
39. Remove the EGR pipe mounting bolts, then remove the EGR pipe.

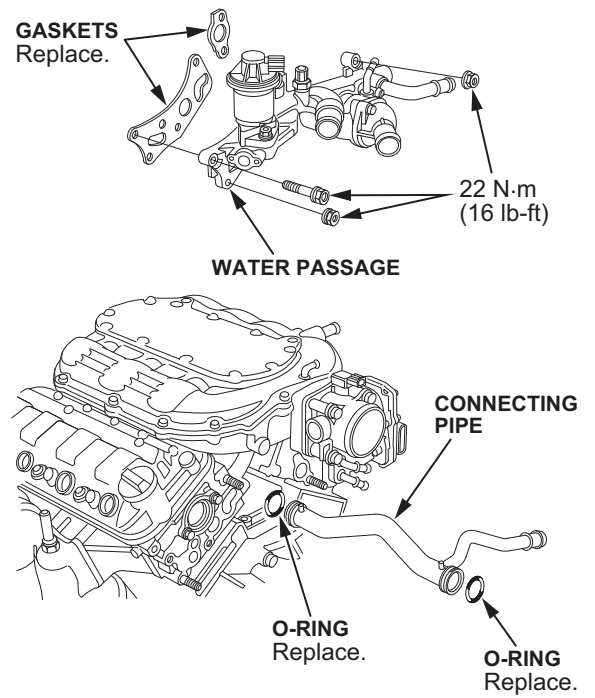
40. Separate the water passage from the heads.

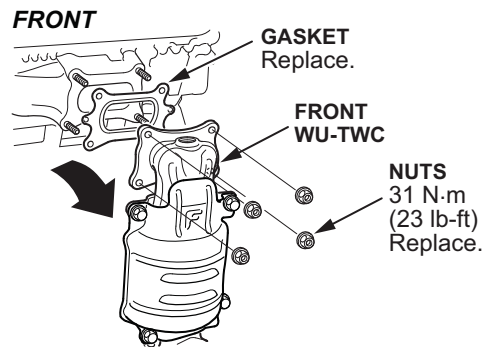
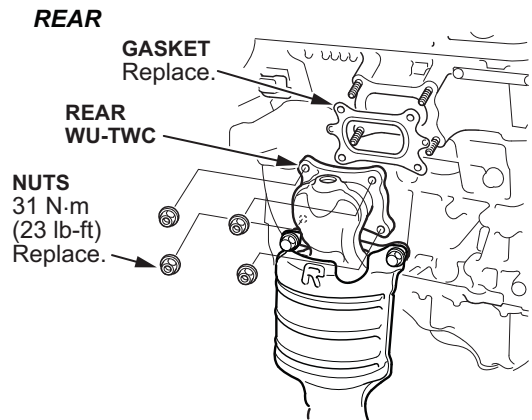
41. Remove the appropriate WU-TWC depending on diagnosis.

NOTE: Set the WU-TWC aside and cover the opening with shop towels to prevent coolant from entering.

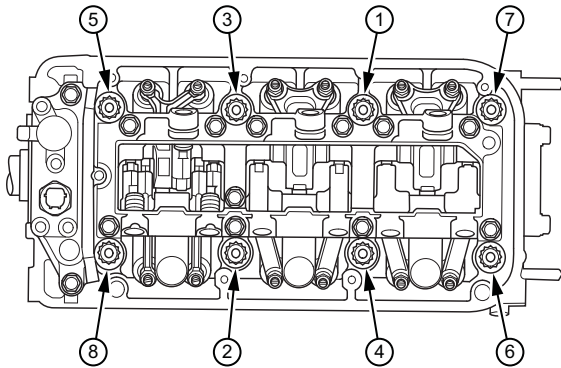
**FRONT**

42. Remove the appropriate head with the injector base attached.

NOTE: Depending on diagnosis, you will remove the rear bank head or both heads.

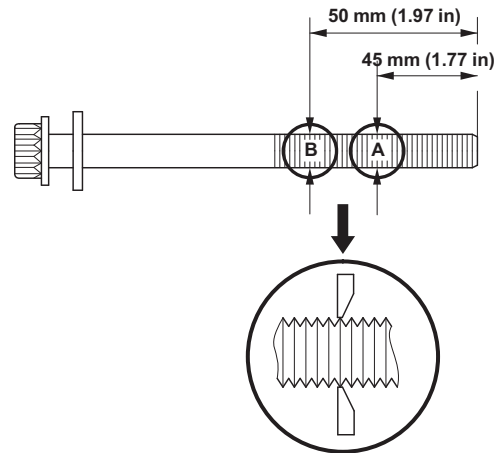
43. Measure the head bolts to determine if they need replacement. If either diameter is less than **11.3 mm (0.445 in)**, replace the cylinder head bolt.

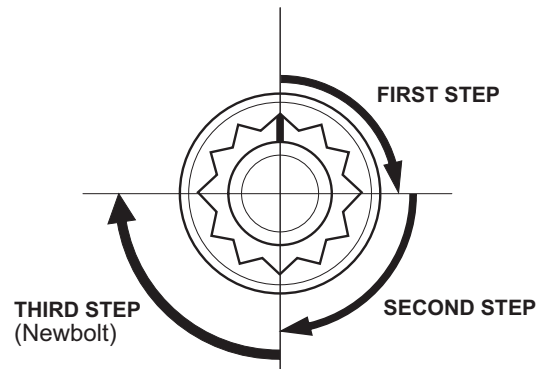
NOTE: Below are the head bolt torque specifications for reinstallation.

- First step: torque the cylinder bolts in sequence to **29 N•m (22 lb-ft)**.
- Second step: tighten in sequence an additional **90 degrees**.
- Third step: tighten in sequence an additional **90 degrees**.
- If the bolts are new, tighten an additional **90 degrees**.

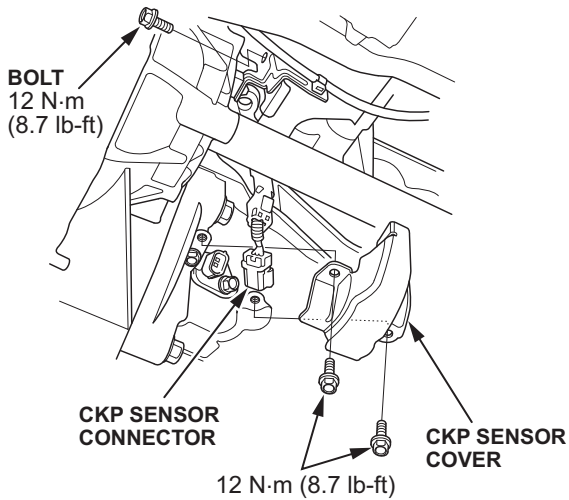
45. Remove the CKP sensor cover and bolts, then disconnect the CKP sensor connector.

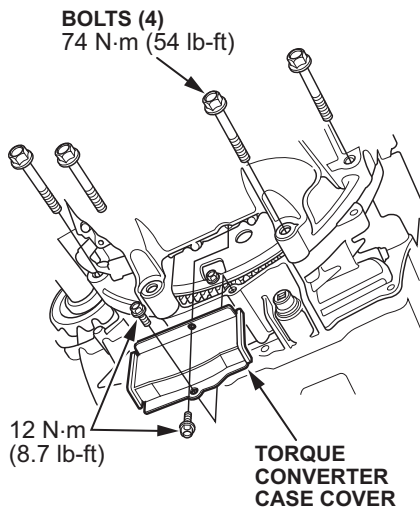
46. Remove the torque converter case cover and the four bolts securing the oil pan to the transmission.

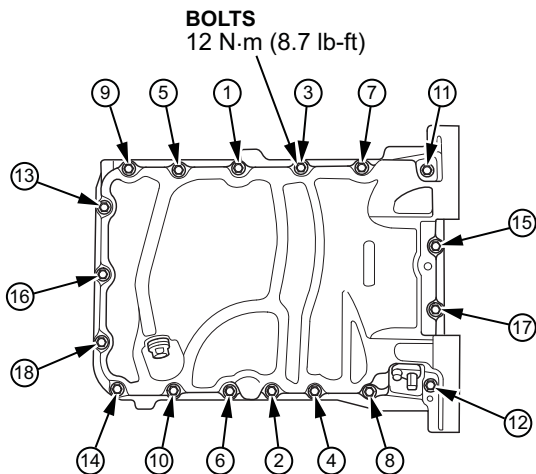
47. Remove all bolts securing the oil pan.

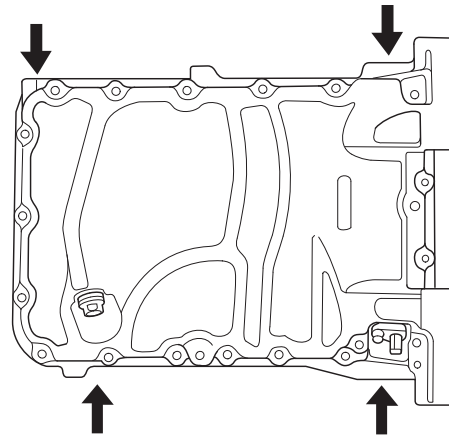
48. Using a flat blade screwdriver, separate the oil pan from the engine block in the areas shown.

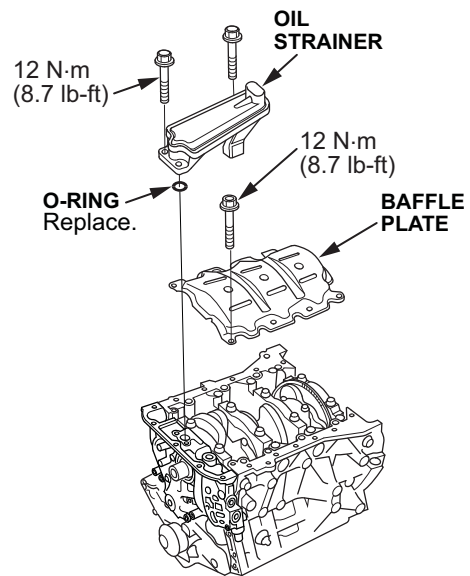
49. Remove the oil strainer and baffle plate.

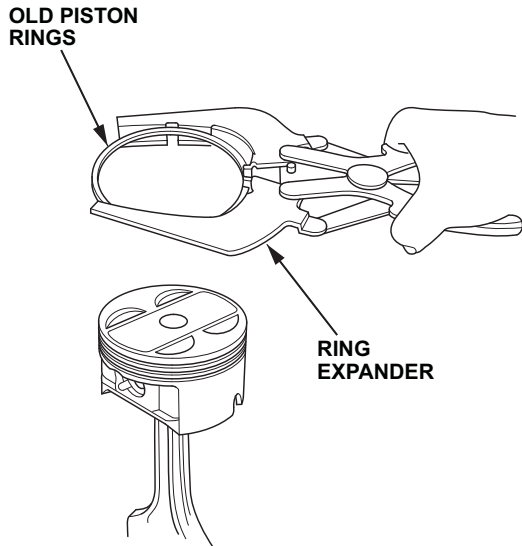
1. Remove the piston rings from the piston using a ring expander. Be careful not to damage the piston.

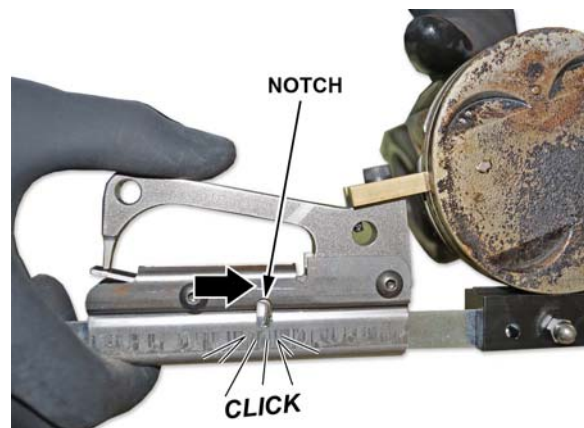
5. Once the cleaning bit is in the appropriate ring grooves of the piston, make sure the tool handle clicks in to place.

NOTE: There is only one notch on the tool for the handle to engage.

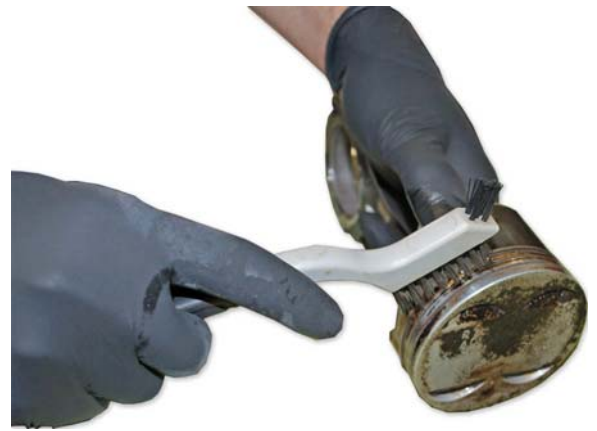
7. Remove the piston groove cleaning tool and clean off the carbon from the tool bit.

8. Finish cleaning the piston with throttle plate cleaner and the nylon brush. **Do not** use a steel wire brush.

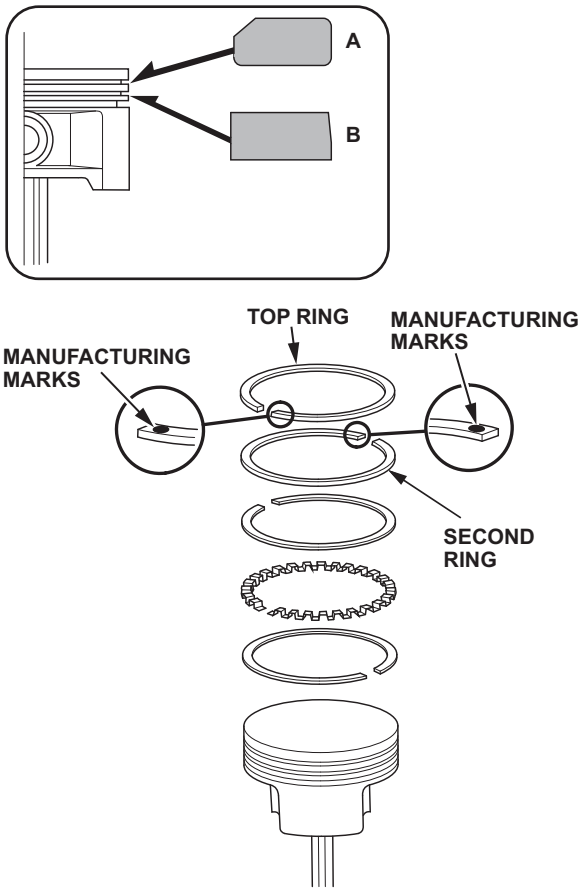
9. Install the piston rings as shown.

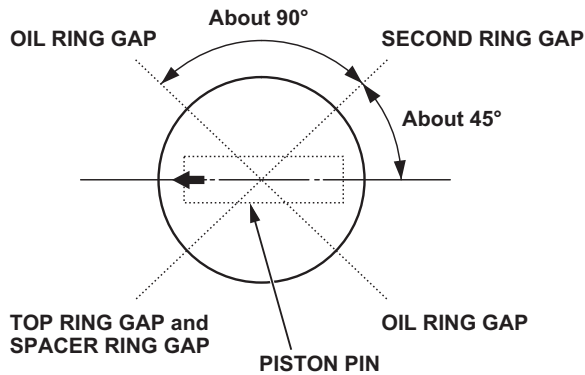
10. Position the ring end gaps as shown.

NOTE: If the ring gaps are not positioned correctly, excessive blowby may occur.

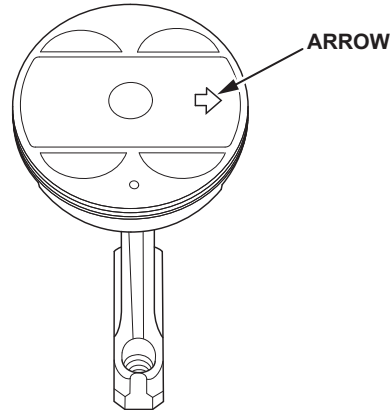
11. Apply new engine oil to the piston, the inside of the piston ring compressor, and the cylinder bore.

12. Install the piston/connecting rod assembly into the cylinder bore with the arrow on top of the piston facing the timing belt side of the engine.

NOTE: Be careful not to damage the cylinder wall when installing the piston.

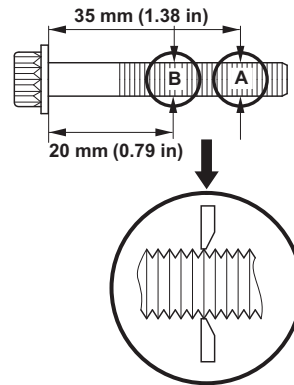
13. Measure the diameter of the connecting rod bolts to determine if they need replacement. Calculate the difference in diameter between point A and point B. It should not be more than **0–0.1 mm (0–0.004 in)**.

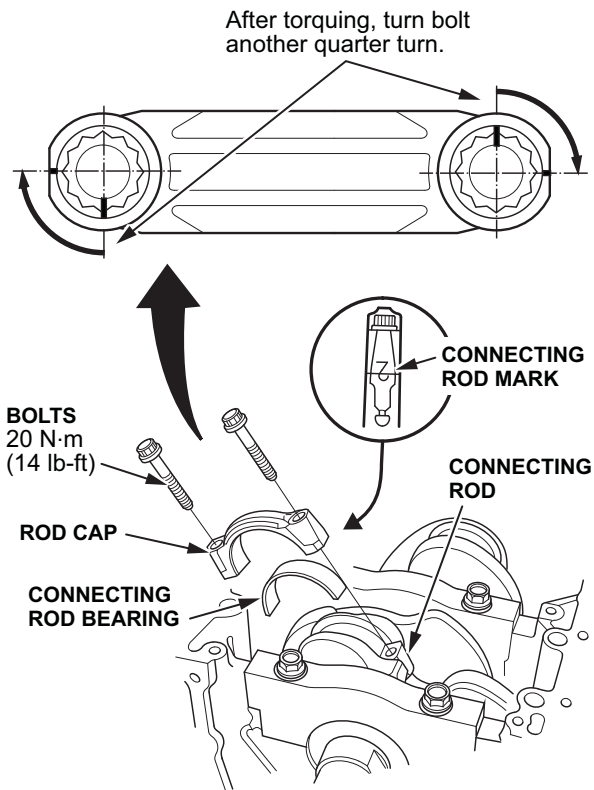
14. Apply new oil to the connecting rod bolt threads and flanges. Torque the bolts to **20 N·m (14 lb-ft)** then tighten the connecting rod bolts an additional **90 degrees**.
